June 28, 2024

Hayward Geologic Hazard Abatement District Board of Directors

Subject: The Reserve (La Vista) Development  
Hayward, California

**HAYWARD GEOLOGIC HAZARD ABATEMENT DISTRICT  
MONITORING – SPRING 2024**

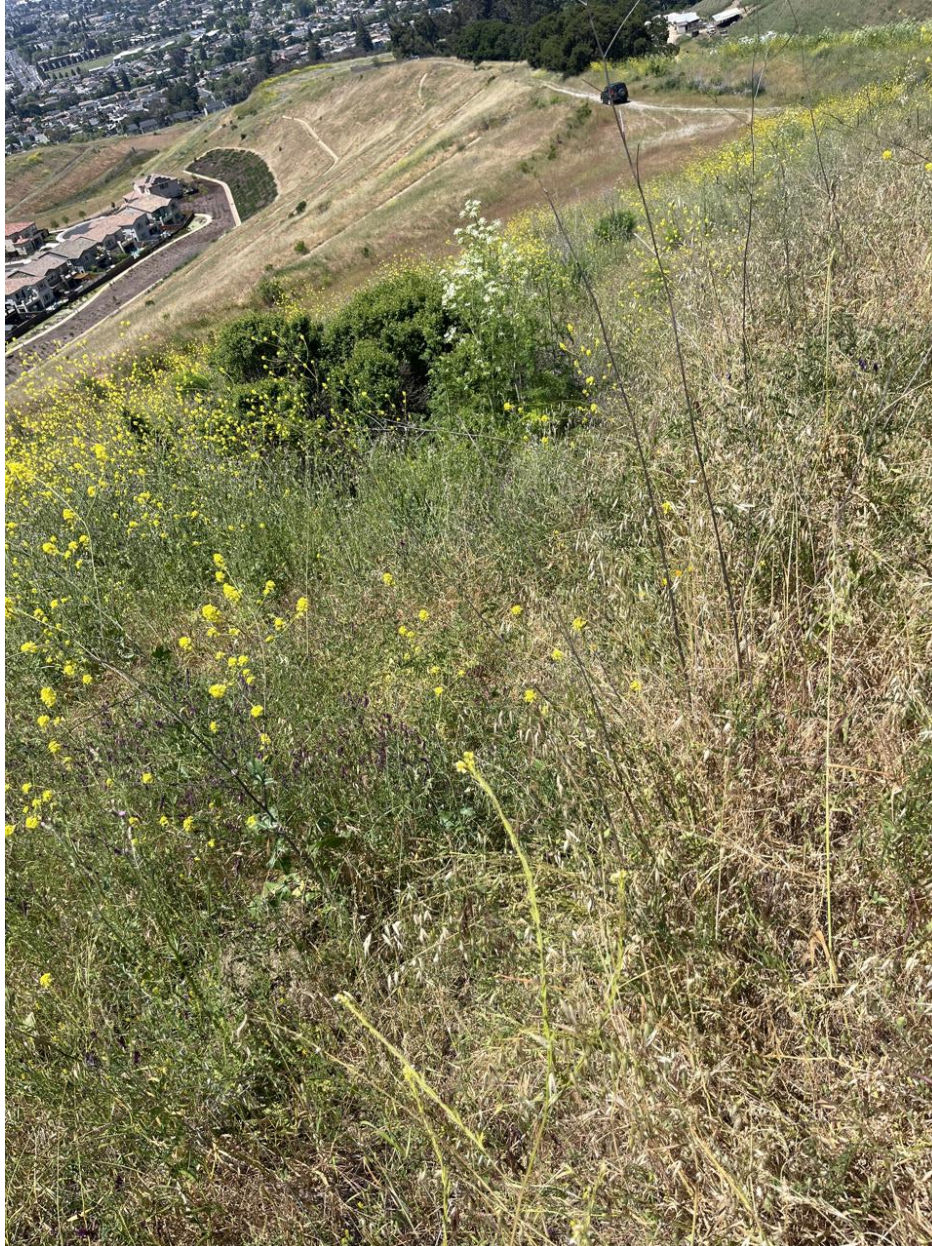
On the current visit, we observed a landslide adjacent to the northern portion of the access road of Parcel 083-75-2-16 (Figure 1, Site Condition A). The slide has a headscarp roughly 30 feet wide and ½ to 1 foot deep, with a toe extending approximately 50 feet down slope. The landslide area does not immediately threaten the stability of the access road nor threaten to mobilize downhill since the toe ends at a large flat embankment. On this monitoring trip, we did not observe any additional downslope mobilization. We will continue to monitor the landslide during our scheduled events and will address the condition if it threatens the development.

**PHOTO 1: Site Condition A – Scarp Development adjacent to the Access Road**

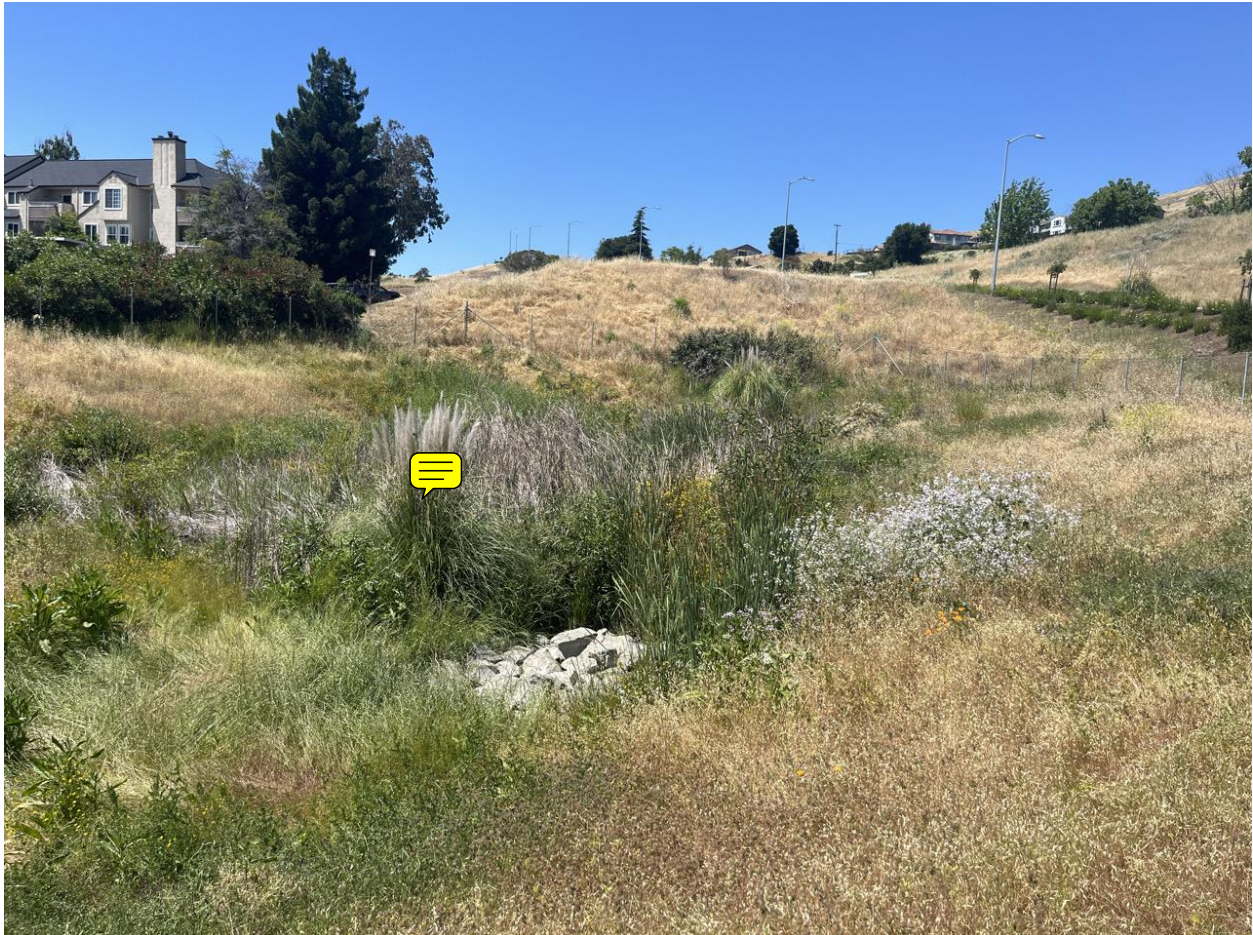
The Alquire water quality/detention basin is located on the southern end of the GHAD boundary on Parcel V (APN 083-480-004), as shown in Figure 1. This basin was inspected for overgrown vegetation, erosion, and proper functioning of inlet and outlet structures. At the time of our monitoring, the basin appeared to be somewhat overgrown, requiring some vegetation cutback.

**PHOTO 2: Site Condition B – Alquire Water Retention/Detention Facility with Overgrown Vegetation**

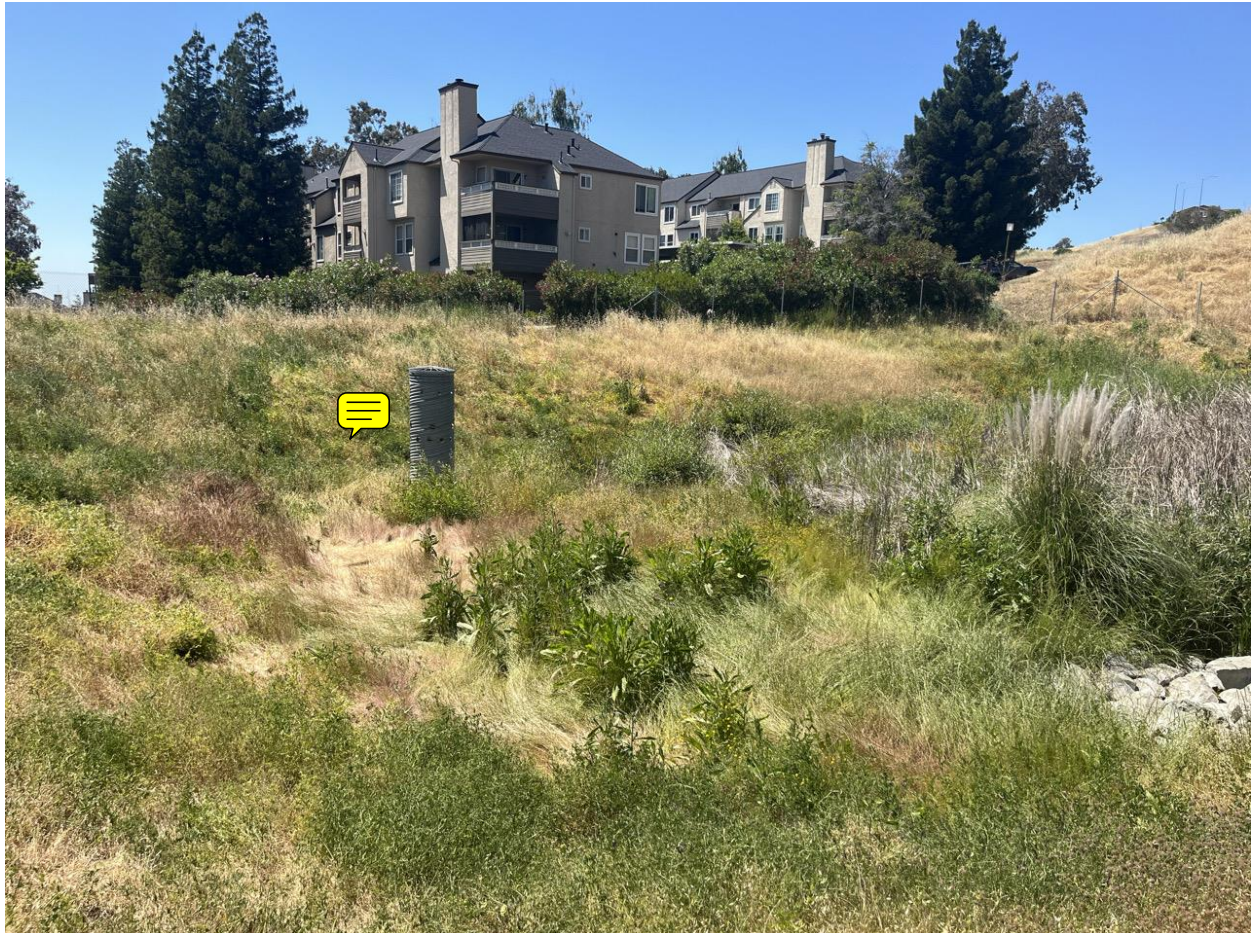
**PHOTO 3: Site Condition B – Alquire Water Retention/Detention Facility with Overgrown Vegetation**

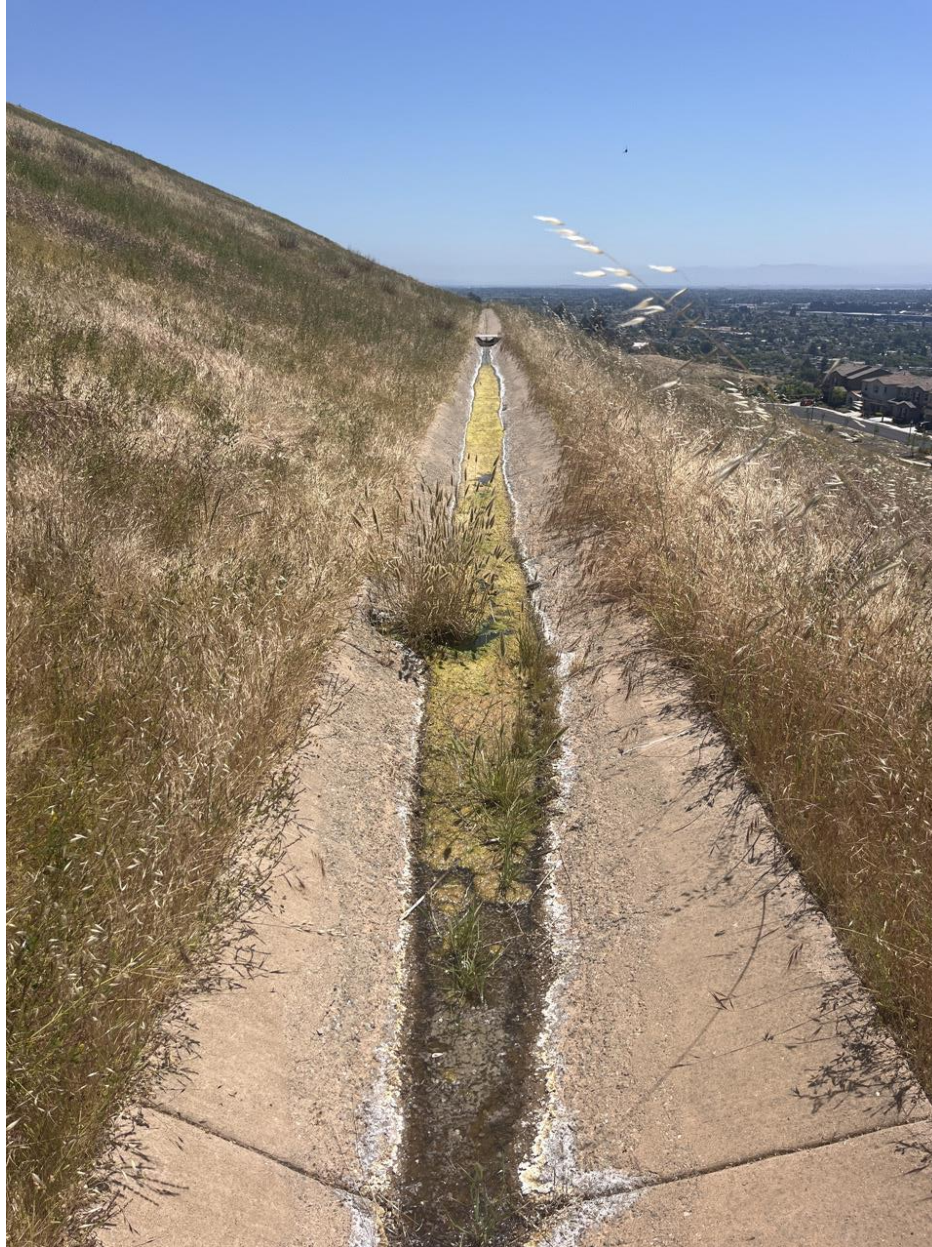
Standing water and extensive moss growth near Subdrain SD-07 outfall appears to be creating issues with the concrete-lined drainage ditch (Figure 1, Site Condition B, Photograph 2). The overgrowth around the subdrain outfall also effects flow. This should be addressed by maintenance to, at a minimum, clean out the concrete-lined ditch and subdrain outlet.

**PHOTO 4: Site Condition C – Standing Water and Overgrowth around Subdrain SD-07 Outlet.**
