Project No.  
**6671.002.024**

Subject: The Reserve (La Vista) Development  
Hayward, California

**HAYWARD GEOLOGIC HAZARD ABATEMENT DISTRICT  
MONITORING – FALL 2024**

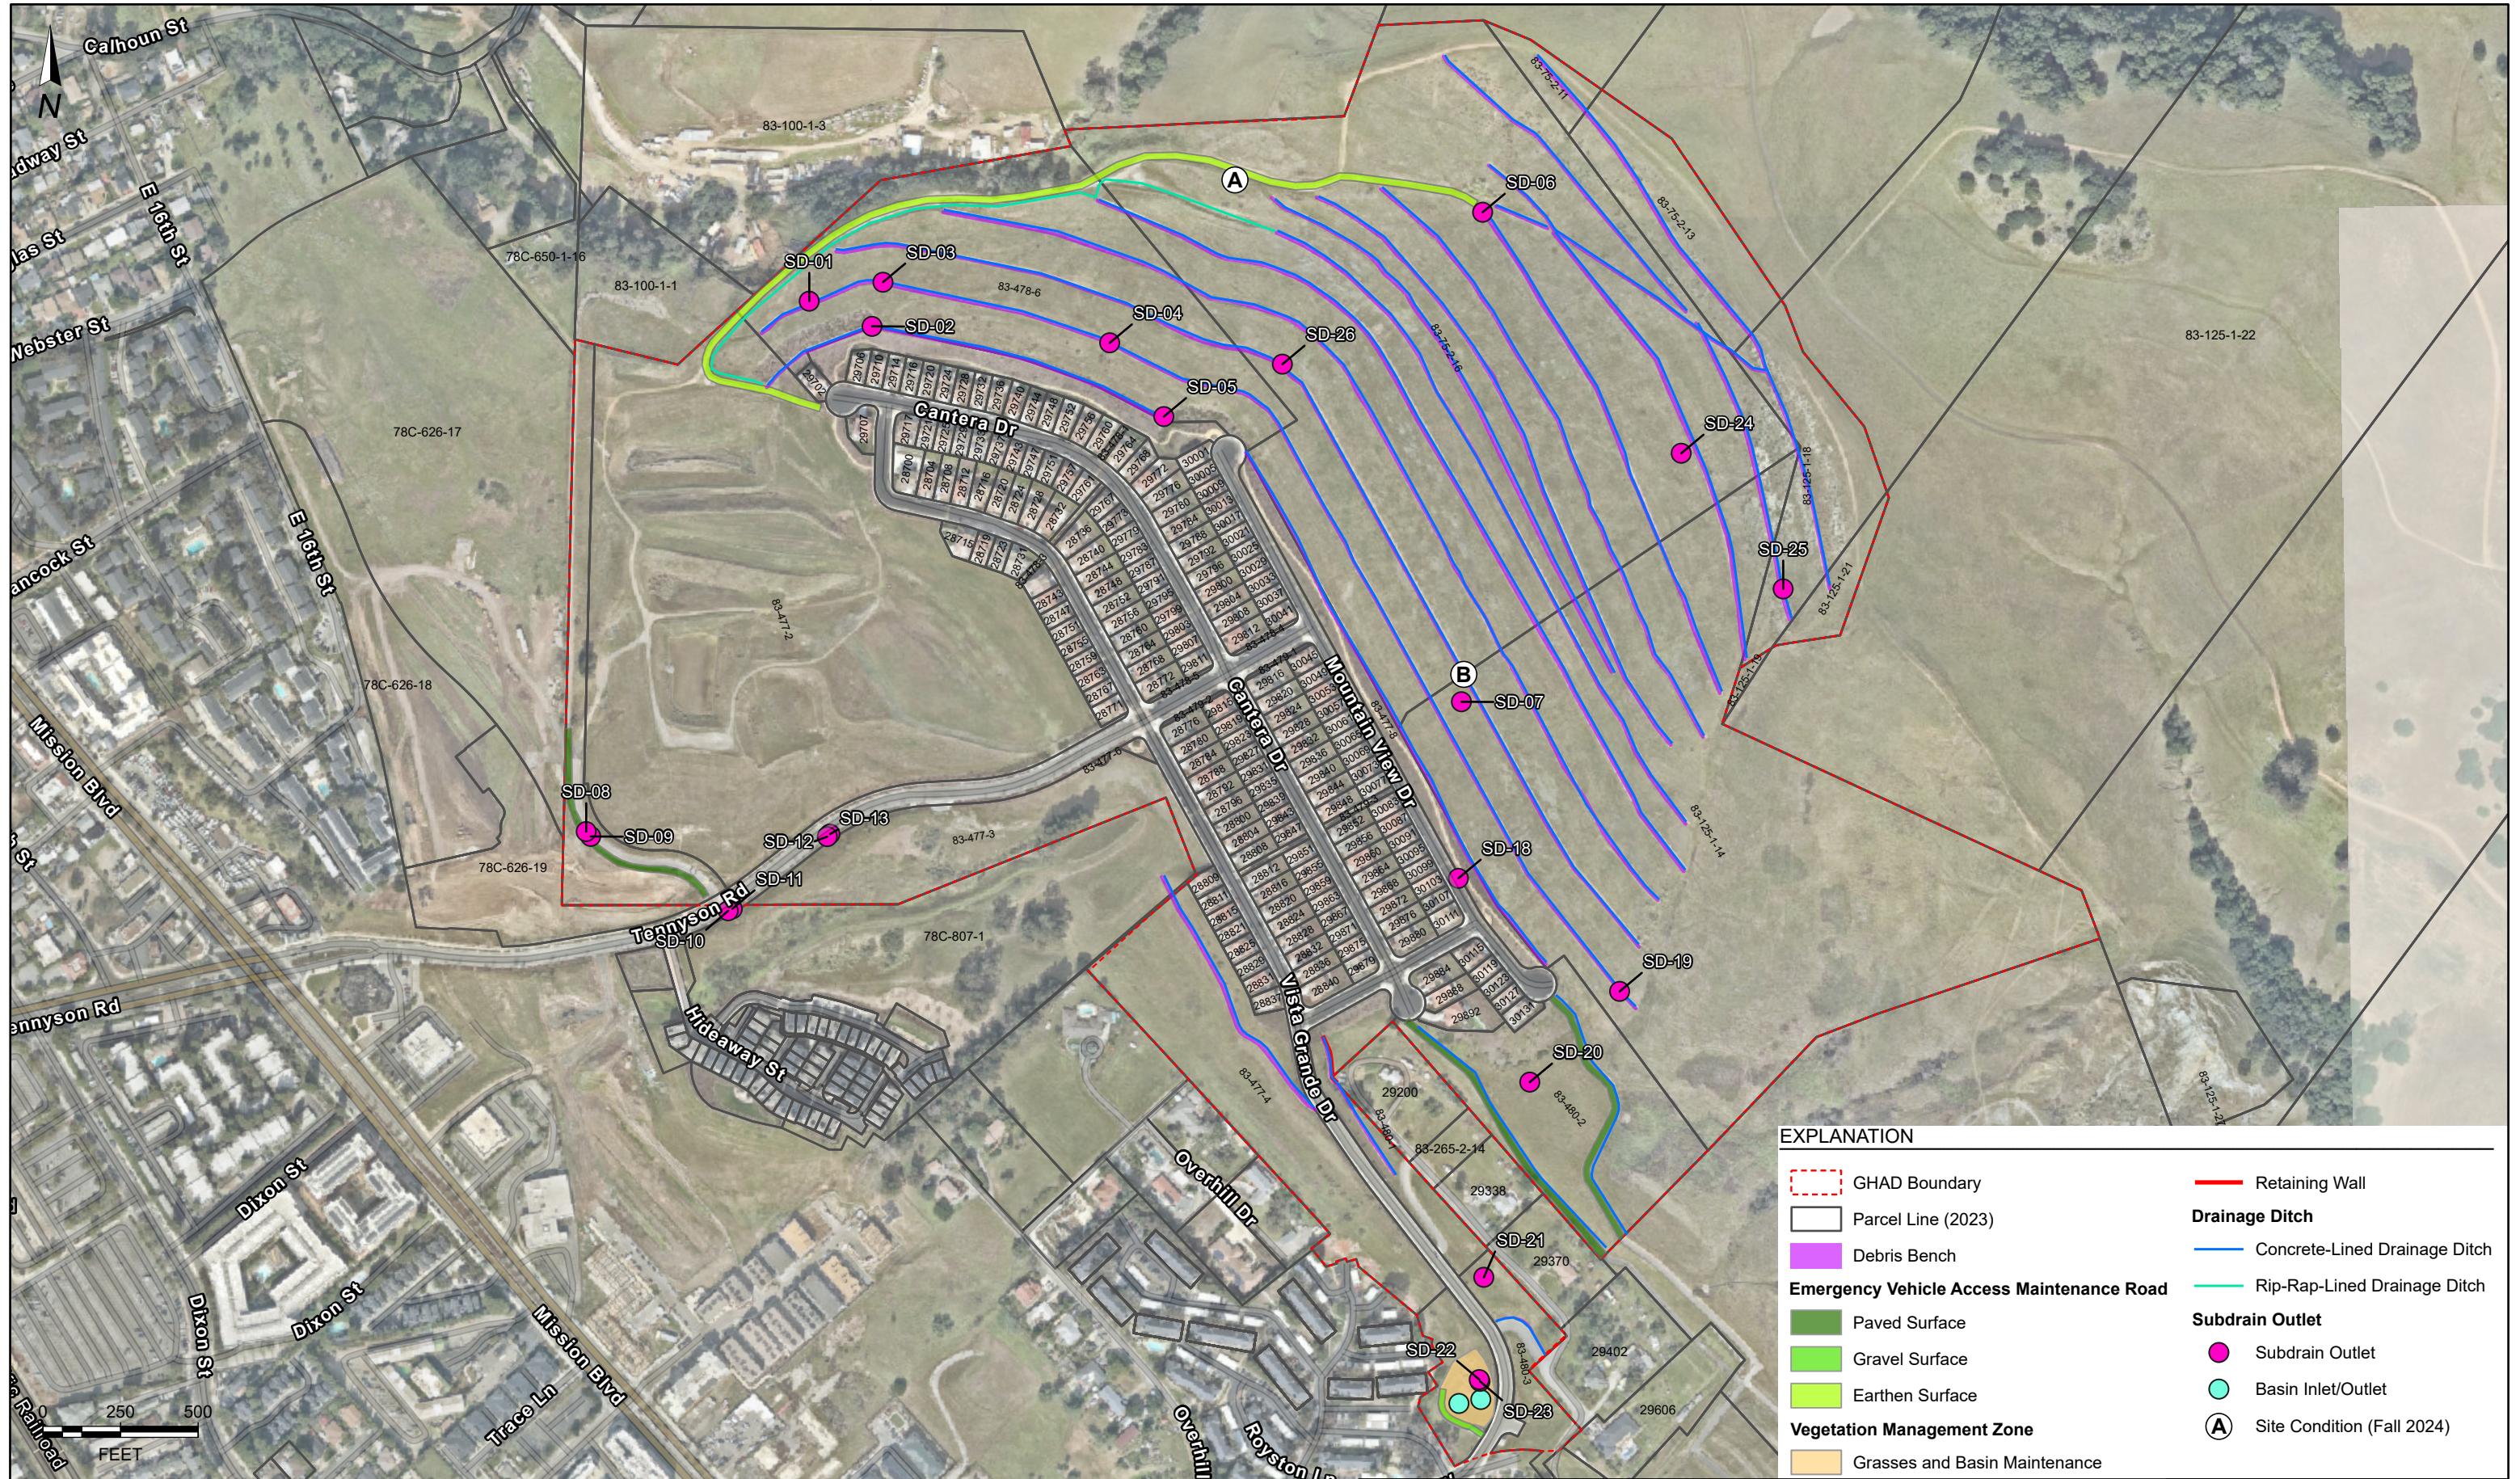
**FIGURE 1**

In our Spring 2024 visit, we observed a landslide adjacent to the northern portion of the access road of Parcel 083-75-2-16 (Figure 1, Site Condition A). The slide has a headscarp roughly 30 feet wide and ½ to 1 foot deep, with a toe extending approximately 50 feet downslope. We observed that the landslide area does not immediately threaten the stability of the access road nor threaten to mobilize downhill since the toe ends at a large flat embankment. In our Fall 2024 monitoring event, we did not observe additional downslope mobilization; therefore, we will continue to monitor the landslide during our scheduled events and will address the condition if it threatens the development.

The debris benches on the slope are shown in Figure 1 and appeared to be performing well. We did not observe any significant accumulation of soil on the benches.

The Alquire water quality/detention basin is located on the southern end of the GHAD boundary, on Parcel V (APN 083-480-004), as shown in Figure 1. This basin was inspected for overgrown vegetation, erosion, and proper functioning of inlet and outlet structures. At the time of our Fall 2024 monitoring, the basin appeared to be somewhat overgrown, requiring some vegetation cutback.

The maintenance roadway (Figure 1) was checked for erosion and signs of distress. During our Spring 2024 monitoring, we noted that erosion gullies had formed along the entire stretch of the road, in some cases up to 1 foot deep. Since then, the road has undergone repairs and the rills have been infilled. At the time of our Fall 2024 visit, the road and adjacent drainage ditches appeared in good condition.

A MSE retaining wall is located on Parcel D (APN 083-480-001) at the southern portion of the site and continuing along Alquire Parkway, as shown in Figure 1. The wall was observed for signs of distress. At the time of our Fall 2024 monitoring event, the MSE retaining wall appeared to be performing well.
