Project No. **6671.002.025**

Subject: Hideaway Development
 Hayward, California

**HAYWARD GEOLOGIC HAZARD ABATEMENT DISTRICT
 MONITORING – FALL 2025**

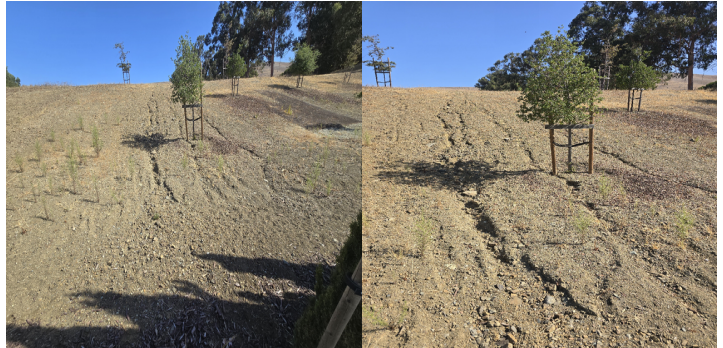
Slopes within the accepted parcels appeared to be performing well without significant evidence of failure that would impact developed areas. We noted during our Spring 2025 monitoring that minor rilling measuring approximately up to 20 feet long and up to 1 foot wide (Figure 1, Site Condition A, Appendix A) occurred on the gentle slope above the earth-lined drainage ditch on Parcel M, 78C-807-1. During our Fall 2025 monitoring, the condition remained relatively unchanged. We will continue to monitor the condition of the rilling on the slope during future monitoring events.

Site Condition: A
Observation Date: 09/26/2025
Description: Rilling on slope above earth-lined drainage ditch.
Recommendation: Continue to monitor.
Field Representative: AC

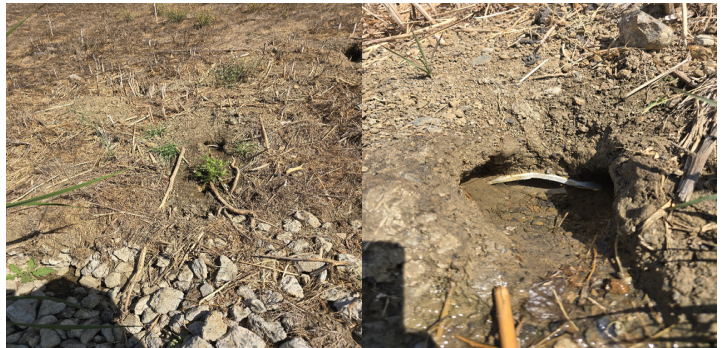
During our Fall 2025 monitoring, we observed the outlet for Subdrain SD-05 was almost entirely buried in sediment (Site Condition B, Appendix A). The GHAD will clear the sediment from the subdrain outlet to restore proper flow and continue to monitor in future events.

Site Condition: B
Observation Date: 09/26/2025
Description: Subdrain outfall approximately 90% buried.
Recommendation: Clear sediment from around outfall and restore rip rap apron.
Field Representative: AC

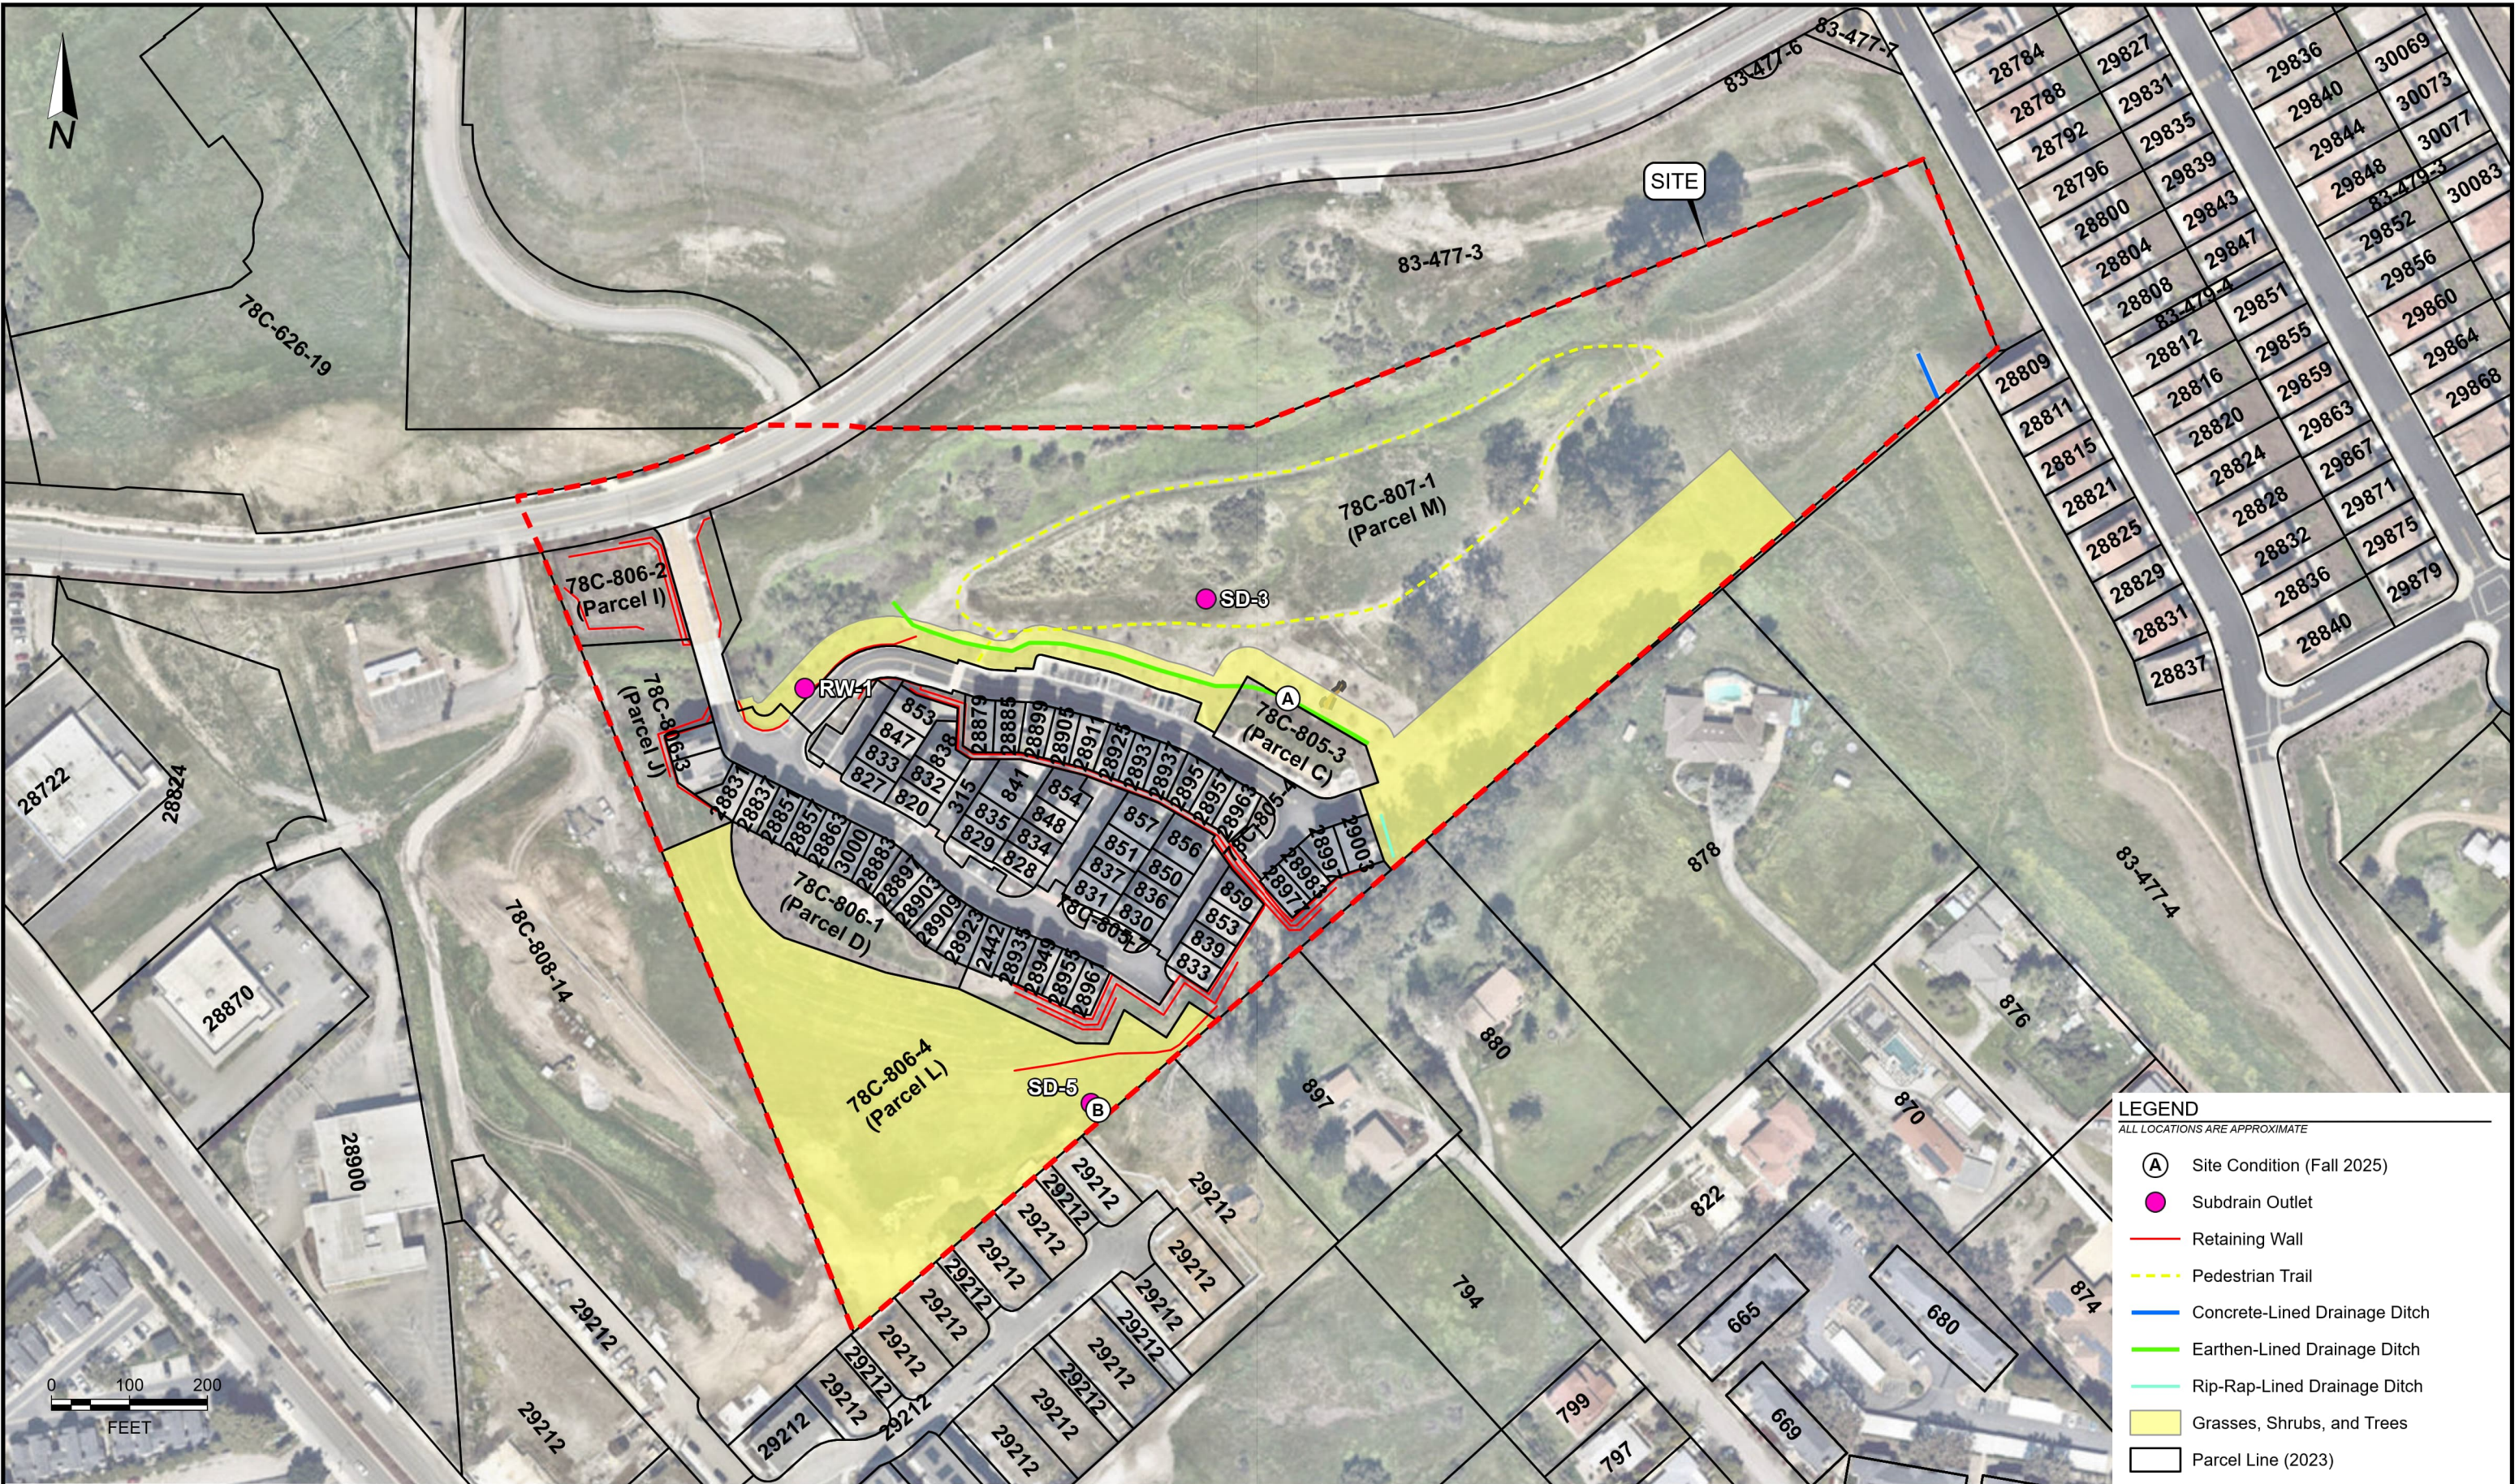
FIGURE NO.
1

The trail (Figure 1) was checked for erosion and signs of distress. During our Fall 2025 monitoring, the trail appeared to be in good condition.

The MSE retaining walls located on Parcel K (APN 78C-805-8) and Parcel M (APN 78C-807-1), shown in Figure 1, were observed for signs of movement and distress. At the time of our Fall 2025 monitoring event, the MSE retaining walls appeared to be performing well.
