Project No. **6671.002.025**

Subject: The Reserve (La Vista) Development  
 Hayward, California

**HAYWARD GEOLOGIC HAZARD ABATEMENT DISTRICT  
 MONITORING – FALL 2025**

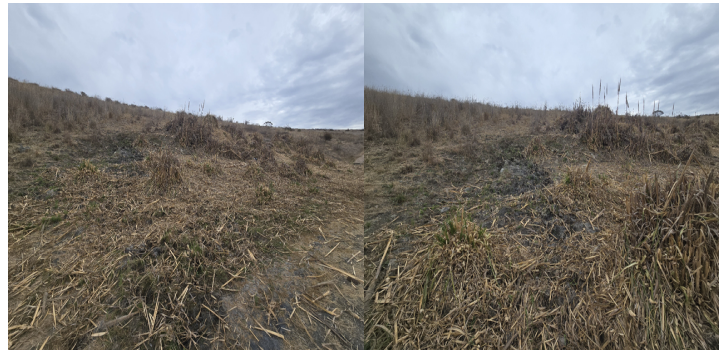
In our Fall 2020 monitoring, a seep was observed on the slope adjacent to the maintenance road on the northernmost end of the site, above Subdrain SD-06 outfall (Site condition A). The growth of pampas grasses continued in the seep area and observed in our Fall 2025 monitoring event. Additionally, upslope of Subdrain SD-19 (Site Condition E) we observed overly saturated soil and dense green vegetation indicative of a water seep. No indications of slope instability were associated with these seeps; however, saturated soil can increase the potential of slope instability, reduce slope performance over time, and lead to slope failures. The GHAD will continue to monitor these locations for indications of slope instability and provide additional subsurface drainage recommendations, as necessary.

Site Condition: A  
Observation Date: 09/24/2025  
Description: Water Seepage in cut slope.  
Recommendation: Continue to monitor.  
Field Representative: AC

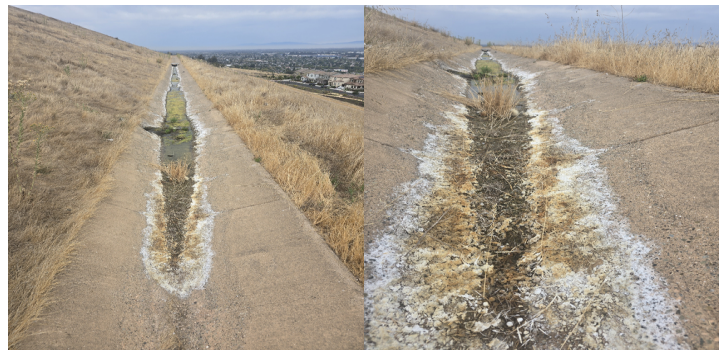
The drainage ditches were checked for accumulation of debris/sediment and for obvious distress, such as cracking or shifting of the concrete. Vegetation adjacent to the ditches was cut and was well maintained for the majority of drainage ditches. Overgrowth and debris in ditches were not observed, and the ditches were properly cleaned. The concrete in the drainage ditch adjacent to Subdrain SD-07 is showing significant deterioration due to prolonged standing water (Figure 1, Site Condition B). This area of the drainage ditch may require future maintenance to restore the concrete and will continue to be monitored during future monitoring.

Site Condition: B  
Observation Date: 09/24/2025  
Description: Concrete lined drainage ditch is deteriorated.  
Recommendation: Continue to monitor.  
Field Representative: AC

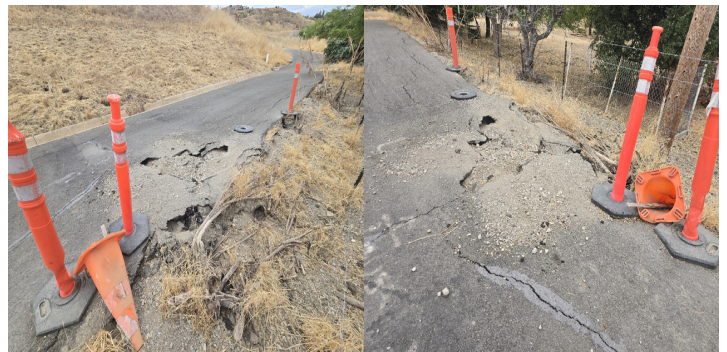
During a previous monitoring event, longitudinal cracks were observed along the paved maintenance roadway located near the cul-de-sac of Cantera Drive and in Parcel N (APN 083-480-002). The paved roadway is situated above a slope, which appeared to be in stable condition. During the Spring 2025 monitoring event, we observed cracking and cavities (Site Condition C) on this paved road above (APN 83-265-2-19). The condition has not changed and remains similar during our Fall 2025 monitoring event.

Site Condition: C  
Observation Date: 09/24/2025  
Description: Cracking asphalt along access road.  
Recommendation: Continue to Monitor.  
Field Representative: AC

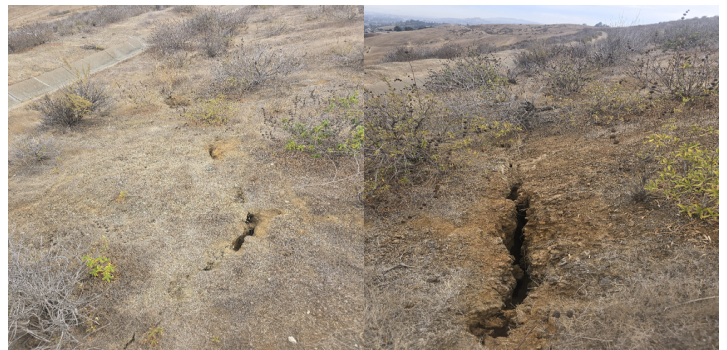
During the Spring 2025 monitoring event, we observed surficial soil movement causing tension cracks at the top of the slope (Site Condition D) above Subdrain SD-25. The cracks measured up to approximately 4 feet deep, 6 feet long, and were scattered across a 50-foot area. During the current monitoring event, we observed the condition has not changed. The distress does not appear to be impacting the stability of the slope or threatening the development and we will continue to monitor the condition during our scheduled events.

Site Condition: D  
Observation Date: 09/24/2025  
Description: Surficial soil movement causing tension cracks, up to 4' deep and 6' long. Spread across a 50' area.  
Recommendation: Continue to monitor.  
Field Representative: AC

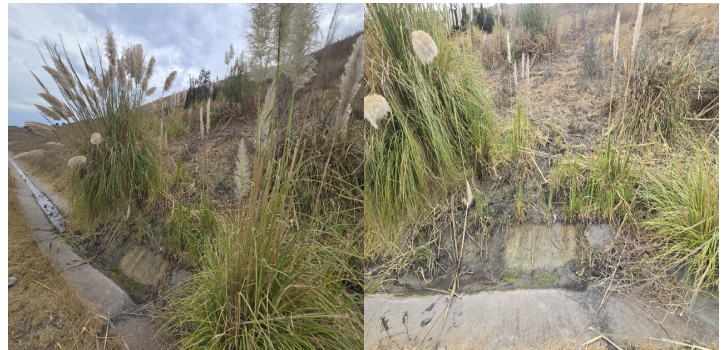
Site Condition: E  
Observation Date: 09/24/2025  
Description: Water seepage in cut slope.

Recommendation: Continue to monitor.
