Project No. **6671.002.025**

Subject: Hideaway Development  
 Hayward, California

**HAYWARD GEOLOGIC HAZARD ABATEMENT DISTRICT  
 MONITORING – SPRING 2026**

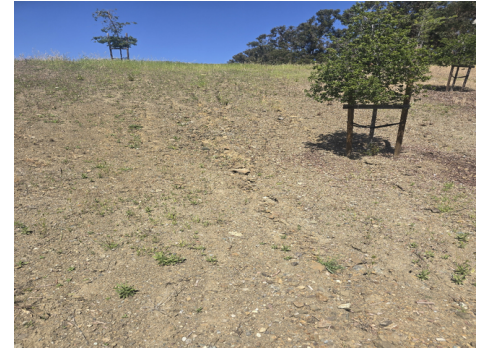
Slopes within the accepted parcels appeared to be performing well without significant evidence of failure that would impact developed areas. We noted during our Spring 2025 monitoring that minor rilling measuring approximately up to 20 feet long and up to 1 foot wide (Figure 1) occurred on the gentle slope above the earth-lined drainage ditch on Parcel M, 78C-807-1. During our Spring 2026 monitoring, the condition remained relatively unchanged (Figure 1, Site Condition A, Appendix A). We will continue to monitor the condition of the rilling on the slope during future monitoring events.

Site Condition: A  
Observation Date: 04/30/2026  
Description: Rilling on slope above earth-lined drainage ditch.

Recommendation: Continue to monitor.

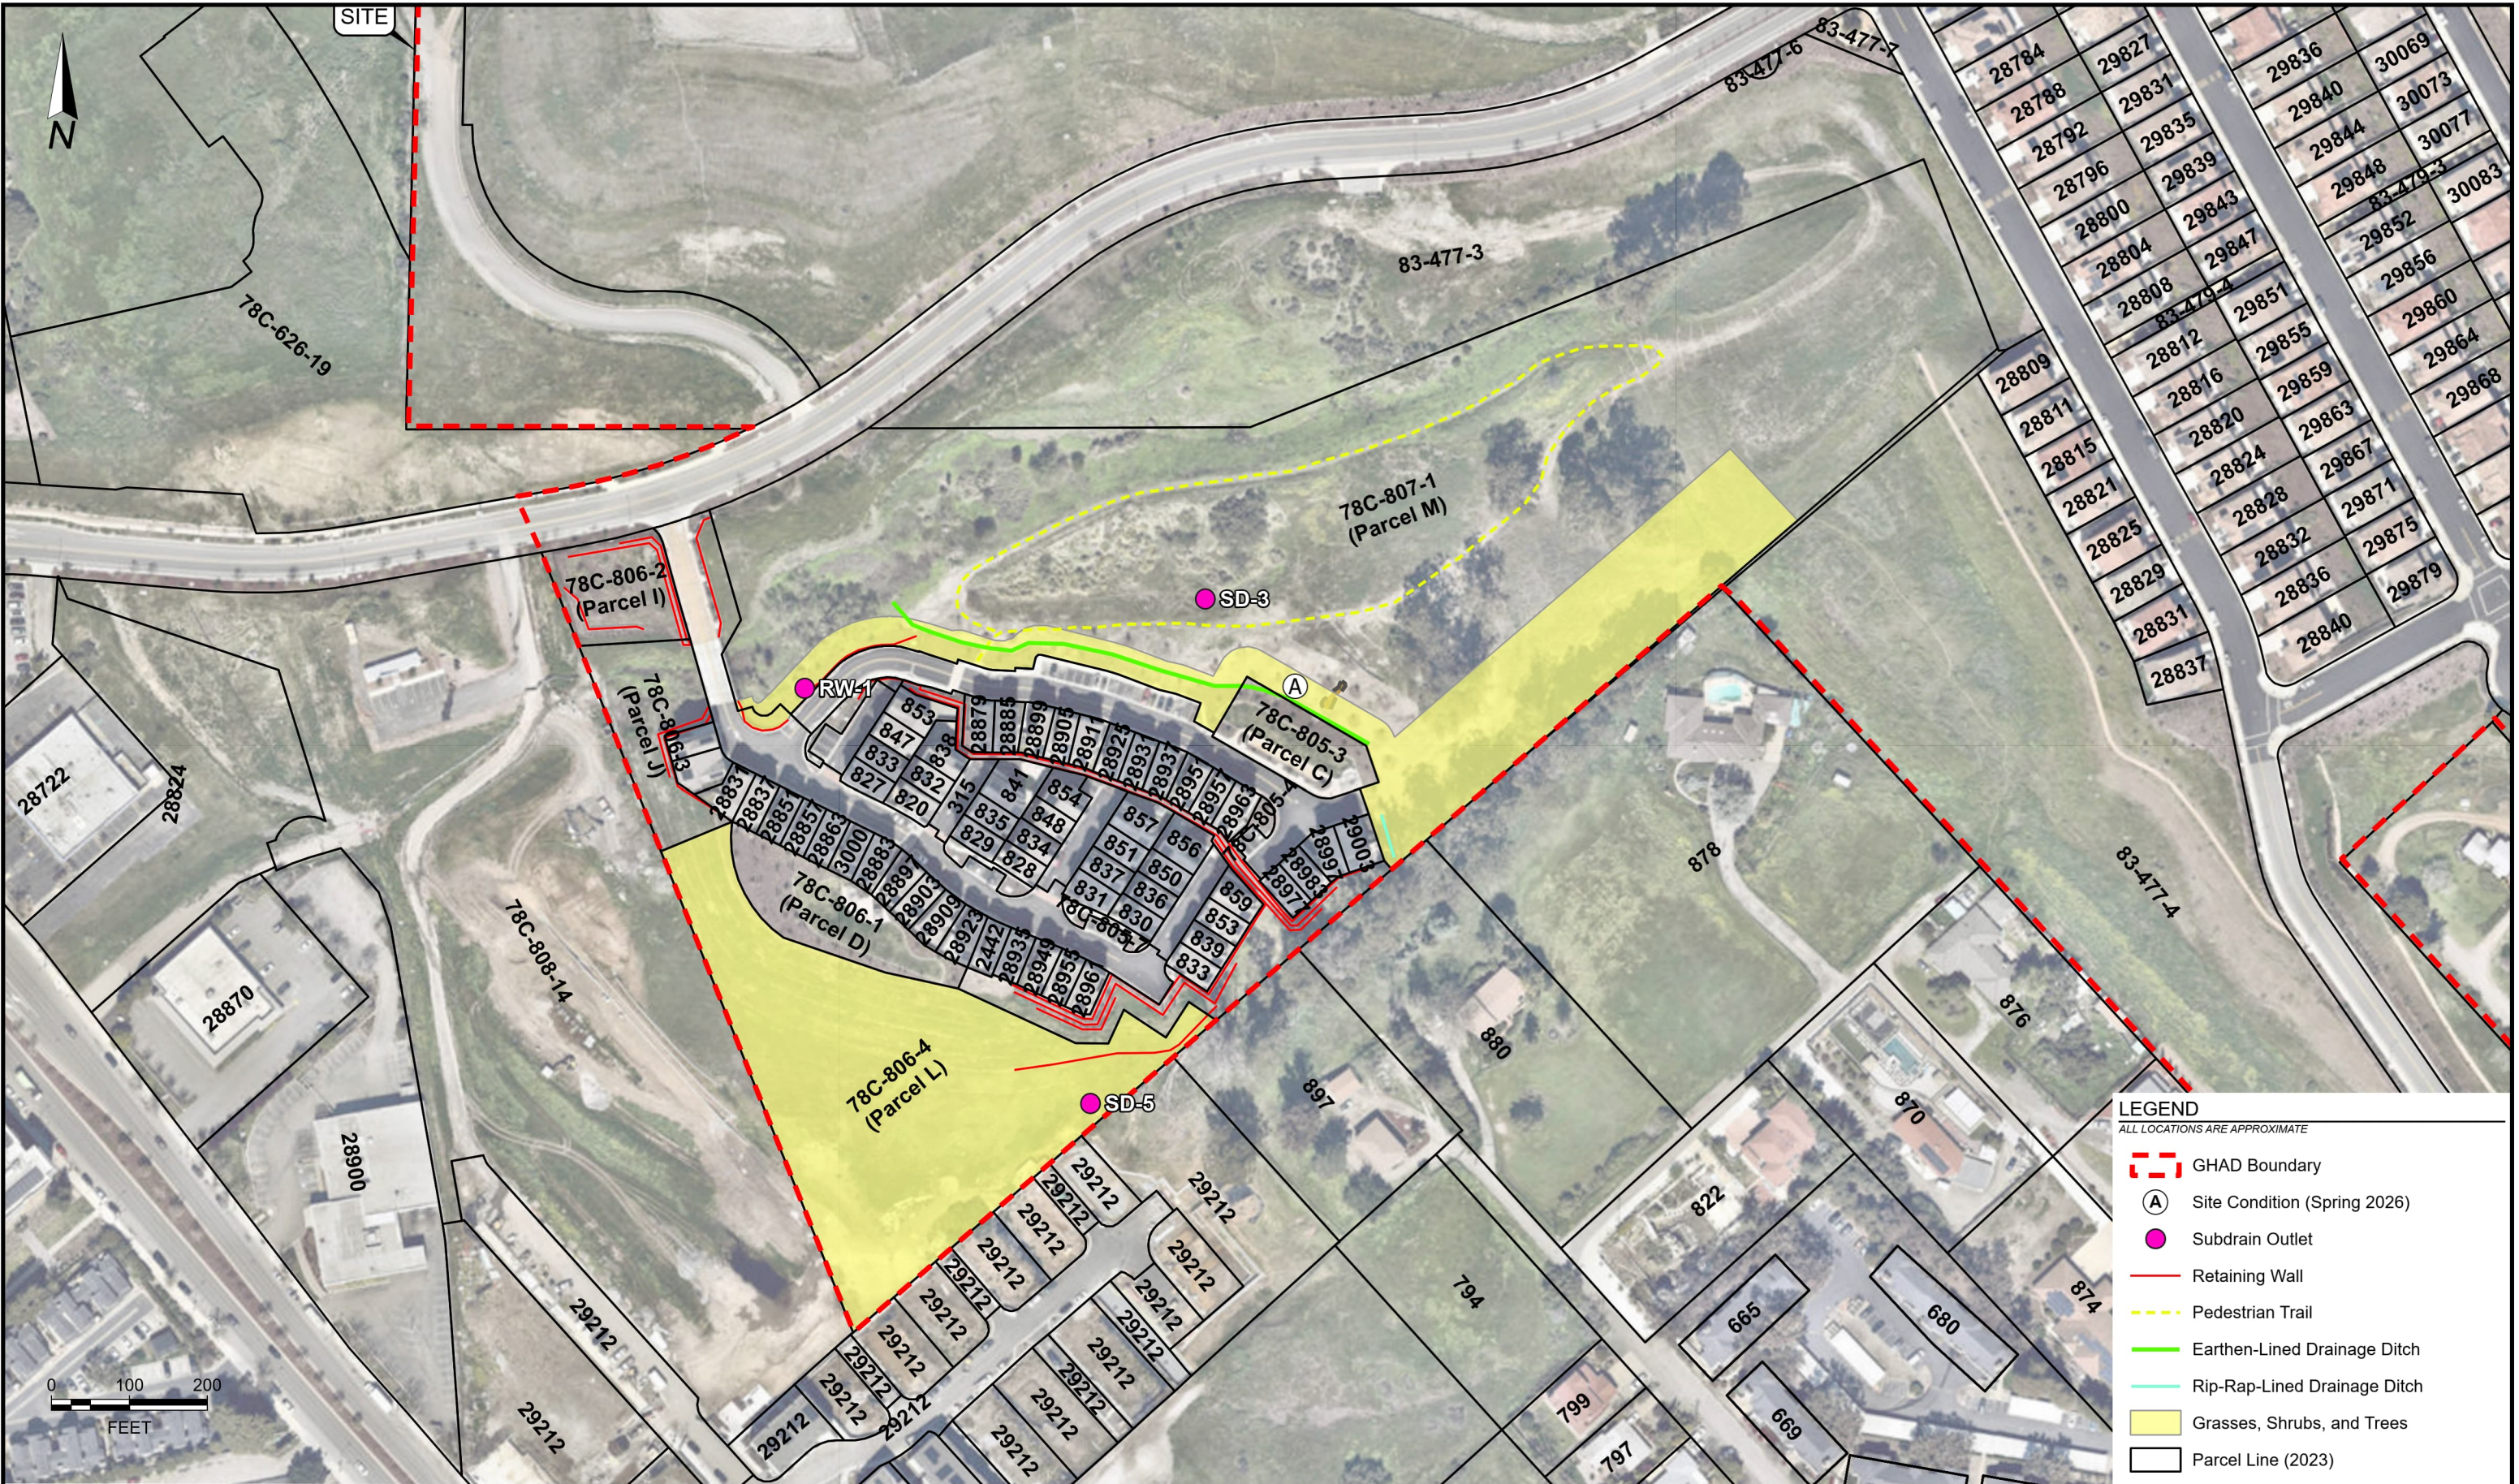
**FIGURE 1**

The MSE retaining walls located on Parcel K (APN 78C-805-8) and Parcel M (APN 78C-807-1), shown in Figure 1, were observed for signs of movement and distress. At the time of our Spring 2026 monitoring event, the MSE retaining walls appeared to be performing well.
