Project No. **6671.002.025**

May 27, 2026

Subject: The Reserve (La Vista) Development
Hayward, California

**HAYWARD GEOLOGIC HAZARD ABATEMENT DISTRICT
MONITORING – SPRING 2026**

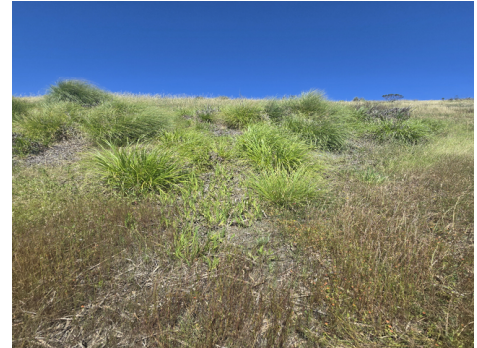
In our Fall 2020 monitoring, a seep was observed on the slope adjacent to the maintenance road on the northernmost end of the site, above Subdrain SD-06 outfall. The growth of pampas grasses continued in the seep area and was observed in our Spring 2026 monitoring event (Site Condition A.1). Similarly, in our Fall 2025 monitoring, we observed overly moist soil and dense green vegetation indicative of a water seep located upslope of Subdrain SD-19, that was still observed in our Spring 2026 monitoring (Site Condition A.2). Lastly, adjacent to Subdrain SD-24, we observed overly moist soil and dense green vegetation indicative of a water seep during our Spring 2026 monitoring (Site Condition A.3).

No indications of slope instability were associated with these seeps; however, overly moist soil can increase the potential of slope instability, reduce slope performance over time, and lead to slope failures. The GHAD will continue to monitor these locations for indications of slope instability and provide additional subsurface drainage recommendations, as necessary.

Site Condition: A.1
Observation Date: 05/07/2026
Description: Water Seepage in cut slope.
Recommendation: Continue to monitor
Field Representative: AC

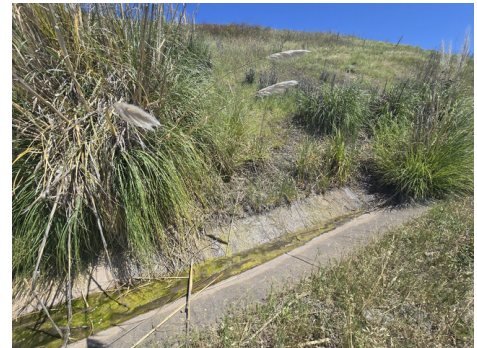
Site Condition: A.2
Observation Date: 05/07/2026
Description: Water seepage in cut slope.
Recommendation: Continue to monitor
Field Representative: AC

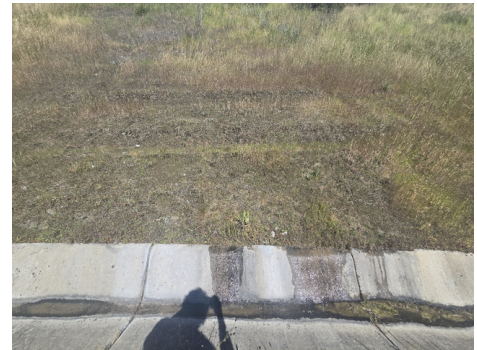
Site Condition: A.3
Observation Date: 05/07/2026
Description: Water Seepage in cut slope.
Recommendation: Continue to monitor
Field Representative: AC

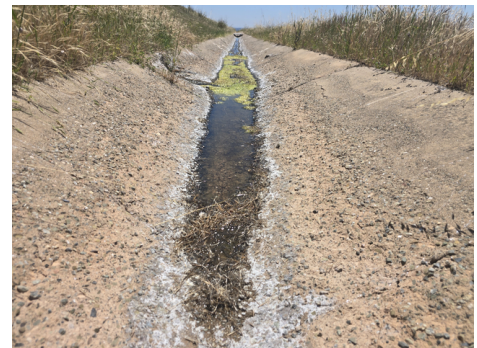
The drainage ditches were checked for accumulation of debris/sediment and for obvious distress, such as cracking or shifting of the concrete. Vegetation adjacent to the ditches was cut and was well maintained for the majority of drainage ditches. Overgrowth and debris in ditches were not observed, and the ditches were properly cleaned. The concrete in the drainage ditch adjacent to Subdrain SD-07 is showing significant deterioration due to prolonged standing water (Figure 1, Site Condition B). This area of the drainage ditch may require future maintenance to restore the concrete and will continue to be monitored during future monitoring.

Site Condition: B
Observation Date: 05/07/2026
Description: Concrete lined drainage ditch is deteriorated.
Recommendation: Continue to monitor
Field Representative: AC

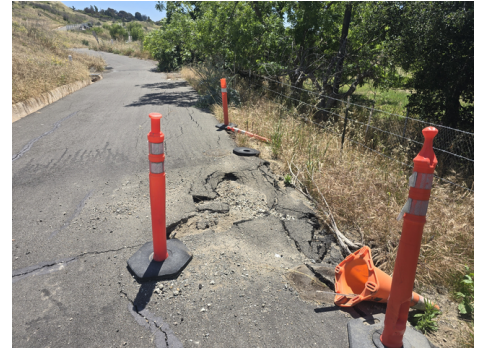
During a previous monitoring event, longitudinal cracks were observed along the paved maintenance roadway located near the cul-de-sac of Cantera Drive in Parcel N (APN 083-480-002). The paved roadway is situated above a slope, which appeared to be in stable

condition. During the Spring 2025 monitoring event, we observed cracking and cavities (Site Condition C) on this paved road above (APN 83-265-2-19). The condition has not changed and remains similar during our Spring 2026 monitoring event.

Site Condition: C
Observation Date: 05/07/2026
Description: Cracking asphalt along access road.
Recommendation: Continue to monitor
Field Representative: AC

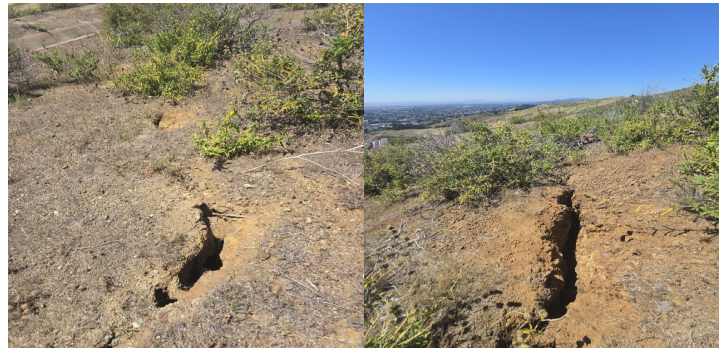
During the Spring 2025 monitoring event, we observed surficial soil movement causing tension cracks at the top of the slope (Site Condition D) above Subdrain SD-25. The cracks measured up to approximately 4 feet deep, 6 feet long, and were scattered across a 50-foot area. During the current monitoring event, we observed the condition has not changed. The distress does not appear to be impacting the stability of the slope or threatening the development and we will continue to monitor the condition during our scheduled events.

Site Condition: D
Observation Date: 05/07/2026
Description: Surface cracks in slope face across 50 foot area.
Recommendation: Continue to monitor
Field Representative: AC

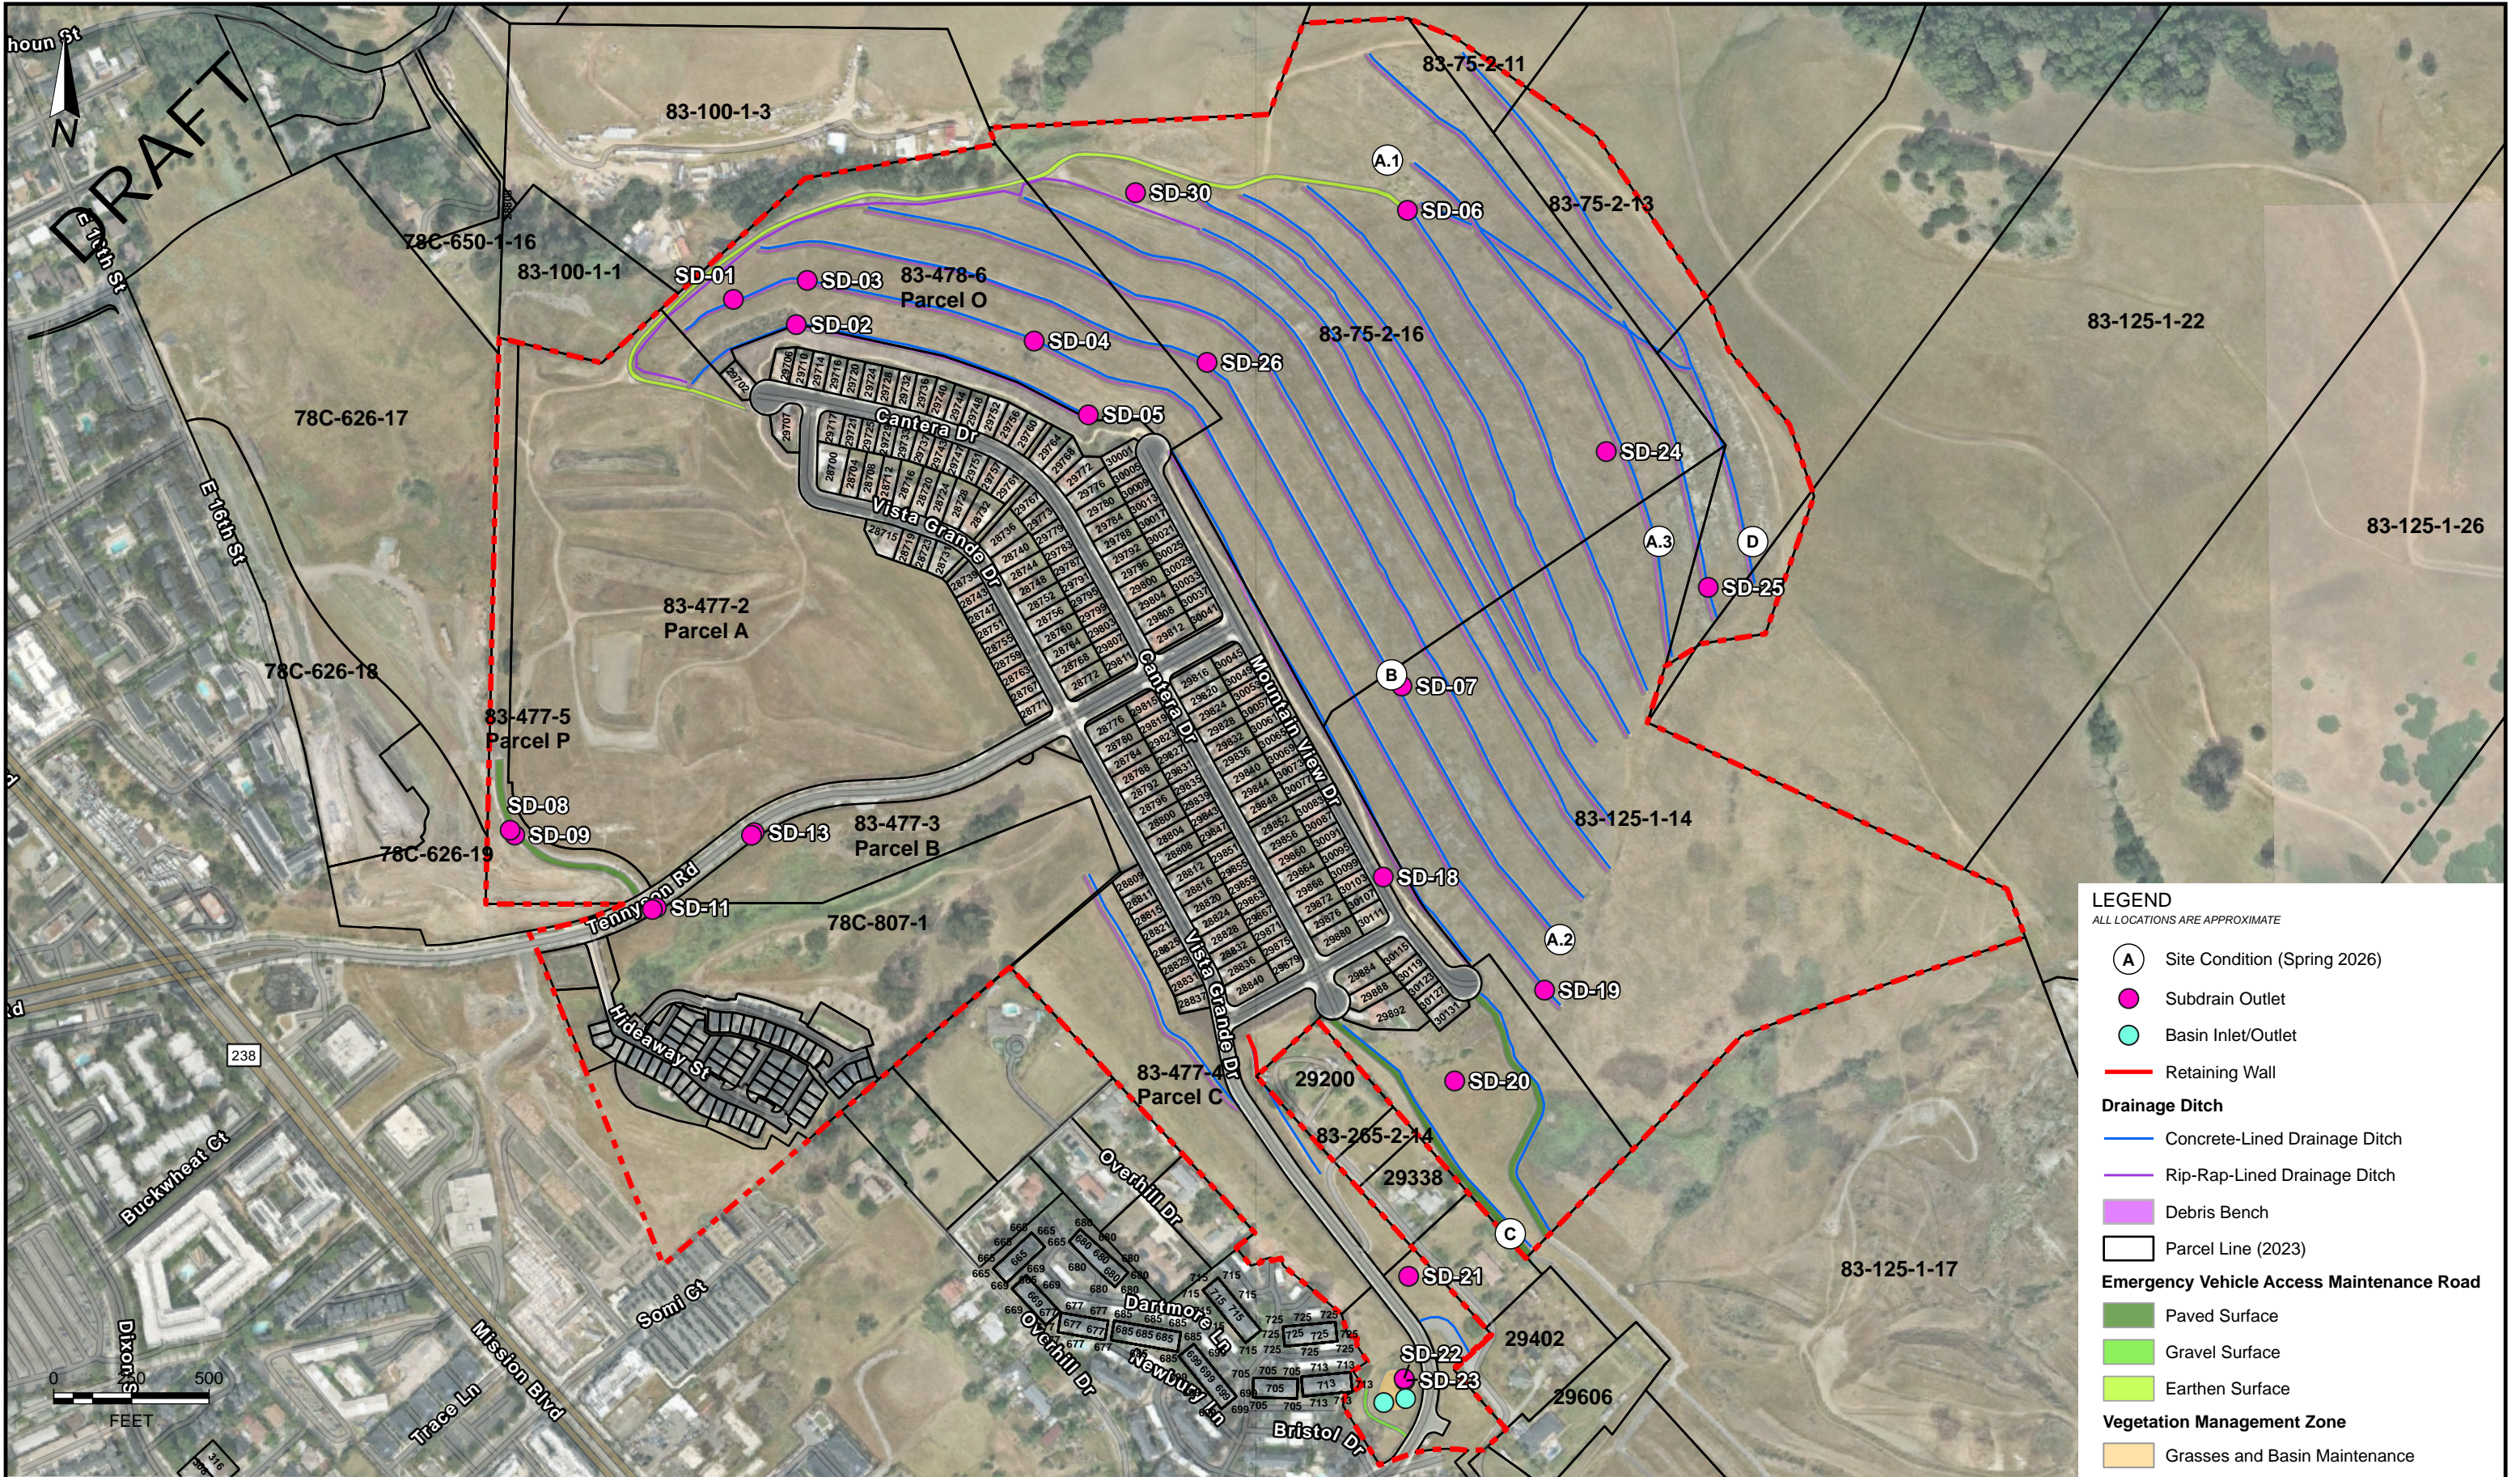
FIGURE 1

The debris benches on the slope are shown in Figure 1 and appeared to be performing well. We did not observe any significant accumulation of soil on the benches.

The Alquire water quality/detention basin is located on the southern end of the GHAD boundary, on Parcel V (APN 083-480-004), as shown in Figure 1. This basin was inspected for overgrown vegetation, erosion, and proper functioning of inlet and outlet structures. At the time of our Spring 2026 monitoring, the basin appeared to be in good working order, requiring no maintenance.

A MSE retaining wall is located on Parcel D (APN 083-480-001) at the southern portion of the site and continues along Alquire Parkway, as shown in Figure 1. The wall was observed for signs of distress. At the time of our Spring 2026 monitoring event, the MSE retaining wall appeared to be performing well.
