Project No. **6671.002.025**

Subject: The Reserve (La Vista) Development  
 Hayward, California

**HAYWARD GEOLOGIC HAZARD ABATEMENT DISTRICT  
 MONITORING – FALL 2025**

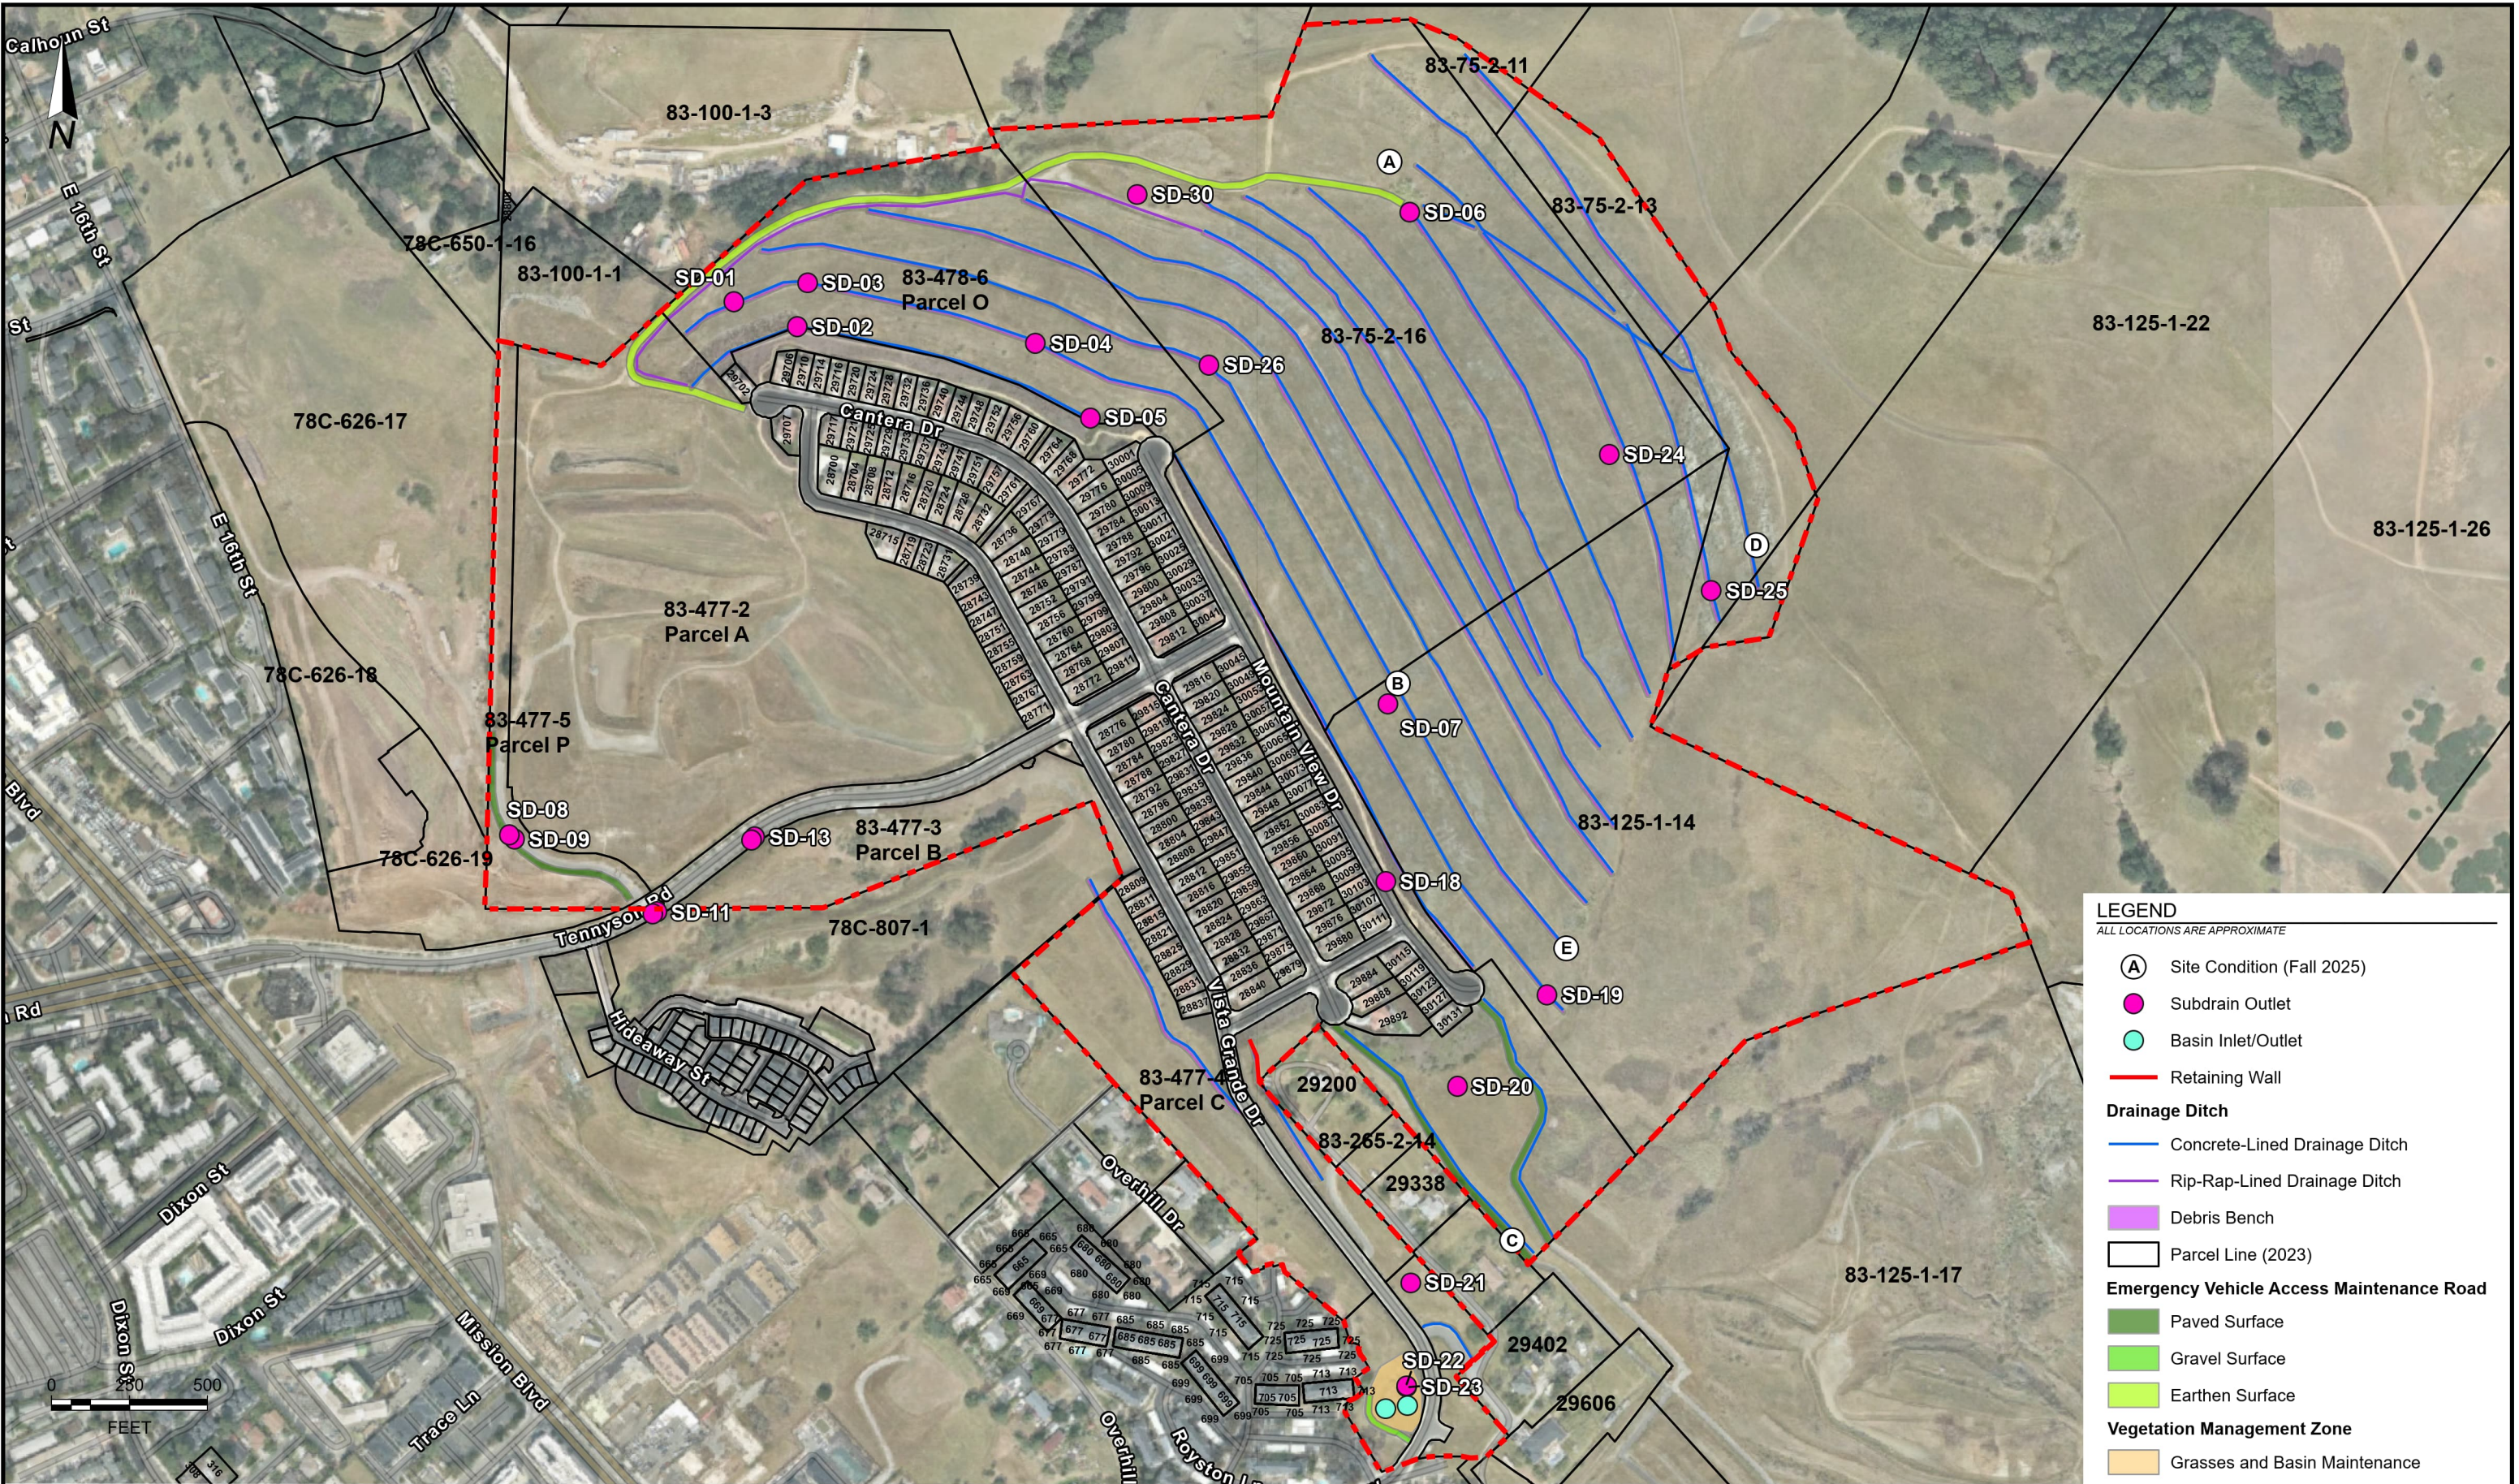
**Site Plan**

The storm drain inlets (Figure 1) were checked for debris accumulation, distress, and proper functioning. At the time of our monitoring, storm drain facilities appeared to be in good condition.

A MSE retaining wall is located on Parcel D (APN 083-480-001) at the southern portion of the site and continues along Alquire Parkway, as shown in Figure 1. The wall was observed for signs of distress. At the time of our Fall 2025 monitoring event, the MSE retaining wall appeared to be performing well.
