**PLAN OF CONTROL
FOR LA VISTA DEVELOPMENT**

**HAYWARD GEOLOGIC HAZARD
ABATEMENT DISTRICT (GHAD)
HAYWARD, CALIFORNIA**

Subject: La Vista Development
Hayward Geologic Hazard Abatement District (GHAD)
Hayward, California

**GEOLOGIC HAZARD ABATEMENT DISTRICT (GHAD)
PLAN OF CONTROL**

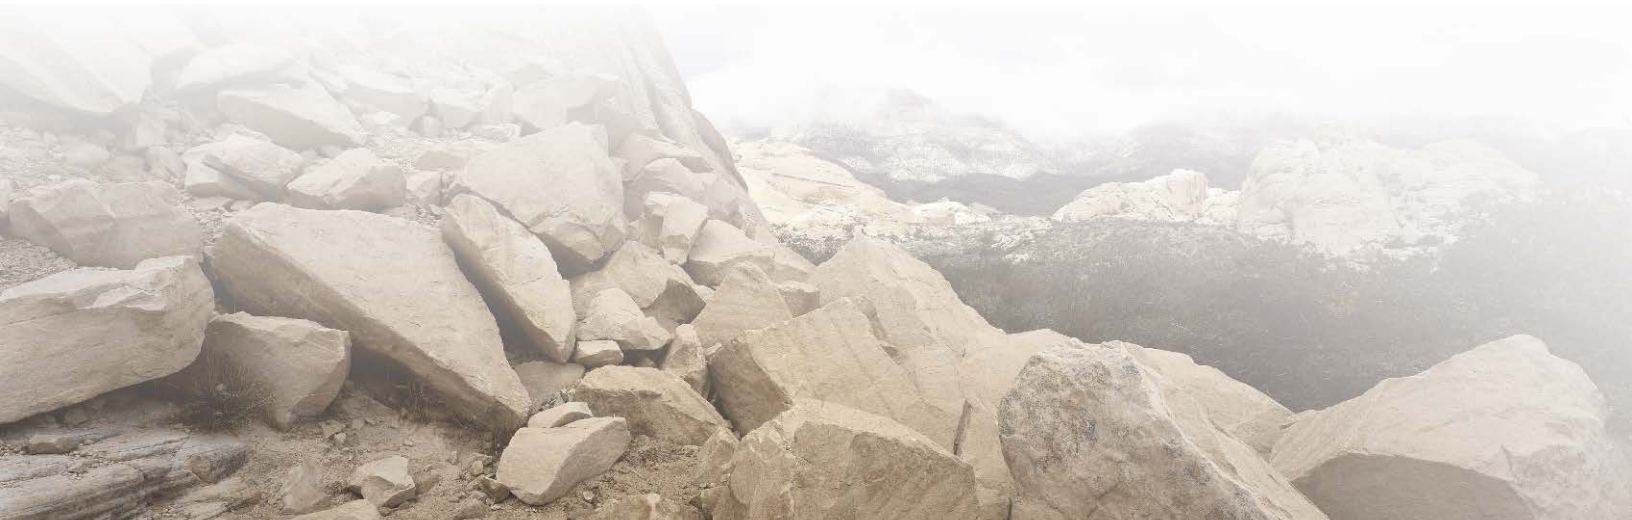
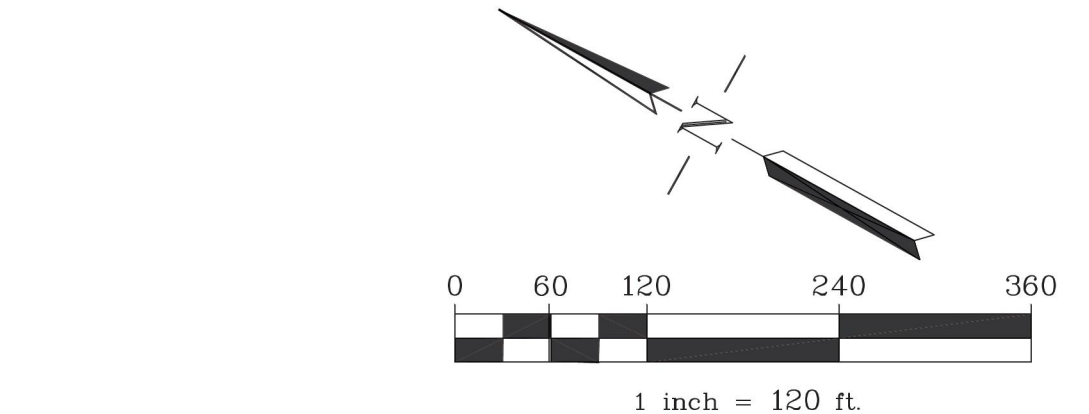
LA VISTA FACILITY MAINTENANCE EXHIBIT

- Figure 1 Facility Maintenance Exhibit
- Figure 2 Geologic Map
- Figure 3 As-Built Subdrain Map

Several entities shall have ownership and maintenance duties of common space within the Project. Other than the GHAD, these entities include a Homeowner’s Association (“HOA”), a Landscape, Lighting, and Irrigation District (“LLID”), the City of Hayward (“City”), and the Hayward Area Recreation District (“HARD”). Landscaping and irrigation within a 100-foot-wide fire break in open space and adjacent to the residential units shall be maintained by the LLID. A Facility Maintenance Exhibit (FME) delineating ownership and maintenance responsibilities is presented in Appendix A, Figure 1.

- Debris benches and walls.
- Subdrains, including, but not limited to, those shown on Appendix A, Figure 3.
- Storm drain inlets, outfalls and pipelines within the GHAD Parcels and a portion of the public park area as shown on Appendix A, Figure 1.

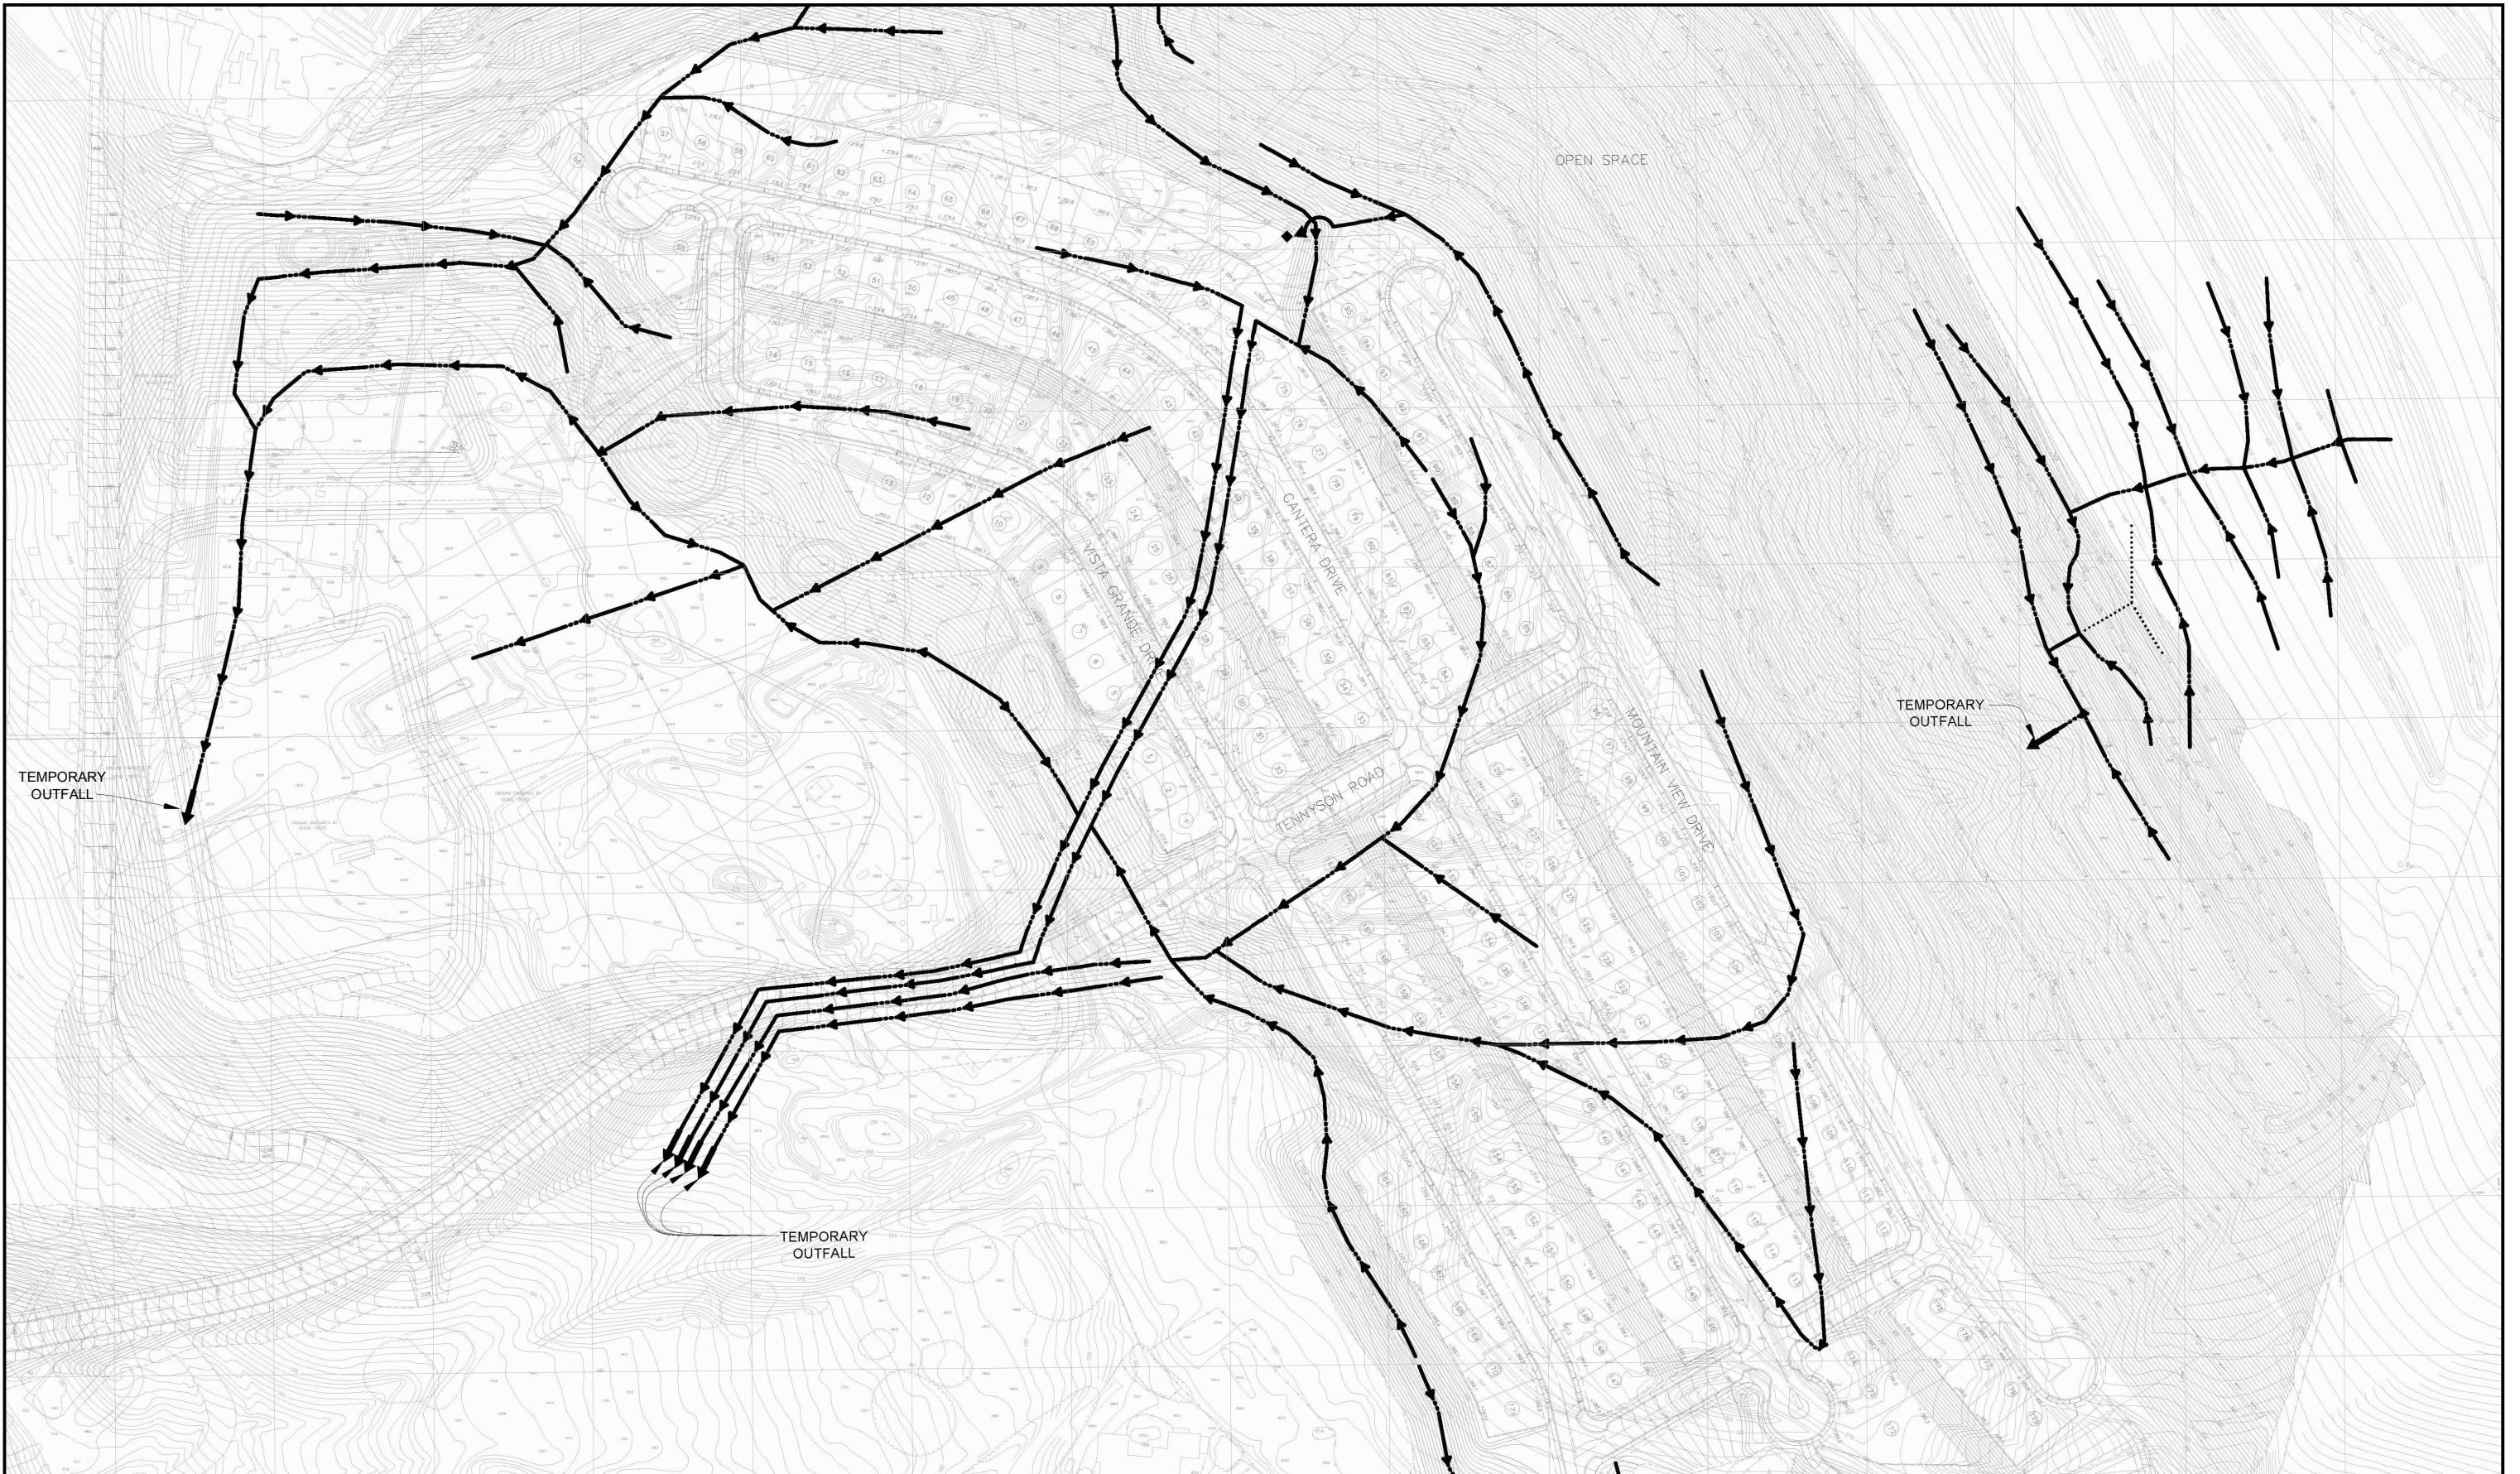
TEMPORARY OUTFALL

The grading also included repair of a landslide that had developed on the reclamation slope in 2005 and installation of a system of subsurface drains throughout the Project. The as-built locations of the drain system are shown on Appendix A, Figure 3.

Landslides located within open space areas are natural landforms that do not require mitigation except where they affect man-made improvements. Debris catchment areas are the principal mitigation method used within the GHAD for areas between potentially unstable slopes and improvements. The debris catchment structures include debris benches, debris berms, and runoff areas. GHAD maintenance of the areas will be critical to maintain adequate protection for the Site Improvements (as such term is defined in Section 5.1). Maintenance and monitoring of these areas is described in Section 9. Potential mitigation and repair measures for GHAD areas near development are discussed in Section 7. A copy of the as-built subdrain plan is shown on Appendix A, Figure 3.
